# Safety Alert

**INCIDENT TITLE:** Wall Mounting Bracket Livening

**TIME AND DATE OF INCIDENT:** 15<sup>th</sup> April 2016

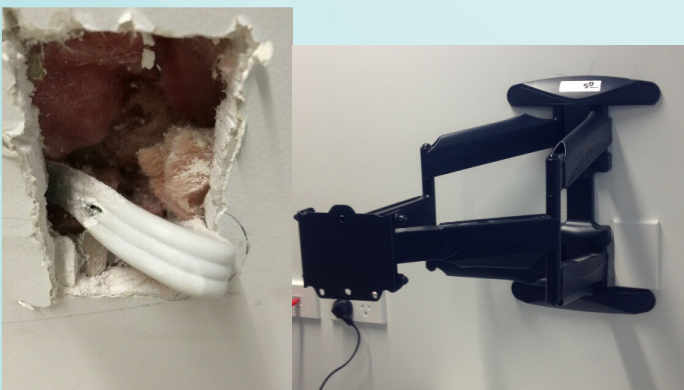
## PHOTOGRAPHS

During the fixing to a wall of an LCD screen mounting bracket, the tip of a fixing screw punctured a phase conductor of a power supply within the wall resulting in livening the wall bracket.

The fault was not immediately known, this meant the mounting bracket was live for a couple of days before being discovered.

The screws used to fix the mounting bracket were longer than necessary

The installer had no information of internal wall services at the time of fixing the mounting bracket

Photographic records or drawings of wall internal services as reference during installation of wall fixed equipment

Installation of RCD protection systems on Electrical supplies
