Trustpower Limited December 2016

## What Happened?

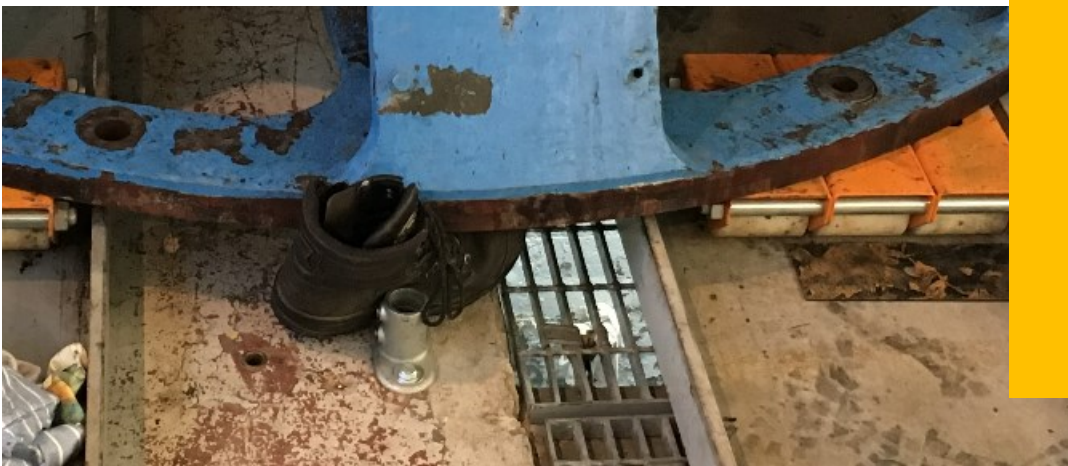
Three staff members were moving a generator stator into a powerstation building on skates. The foot of one of the staff members became trapped between a kee clamp station holder and the moving stator.

Brusing of the foot— has potential to be a lot worse had there been more momentum in the moving stator—Staff member was taken to A&E for X-rays to ensure no broken bones.

Kee Clamp was not considered in the WSP as a possible nip point  
Staff in front of moving load

Lugs on floor for holding safety barrier to be removed until safety barrier is required

Procedure for moving loads on skates will be changed so that no person is in

- Kee Klamp on Floor to be removed and only fitted prior to hatches being opened
- No staff in front of moving load - Moving of the stator will be by pushing from behind only (No pulling from the front)
