WORKER TRAPPED INSIDE BUILDING DUE TO FAULTY DOOR HANDLE/LATCH

8 May 2017, Ngatamariki power station.

Date issued: 19 May 2017

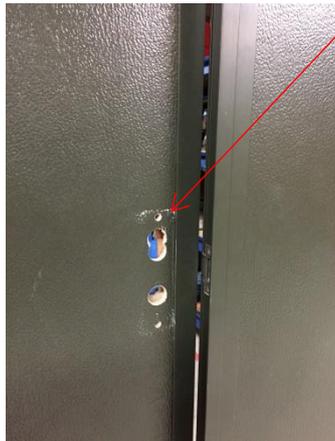
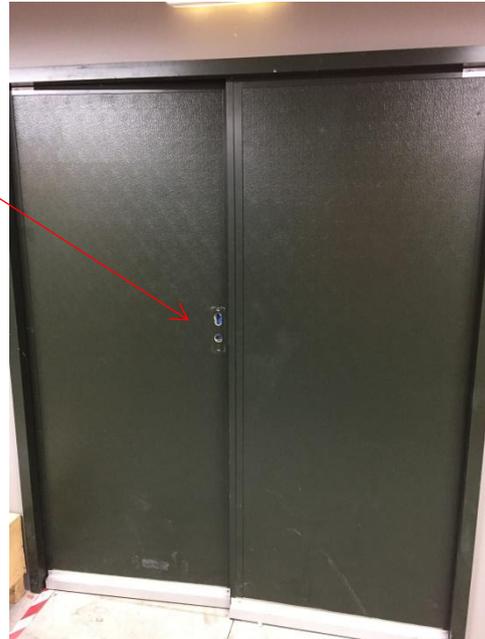
Door after worker had removed the lock

While on site a contractor entered the electrical storeroom for maintenance and closed the door behind him. When the contractor tried to exit the room the handle wouldn't open the latch. There was no second exit in the room, and the contractor didn't have his cell phone on him as he had been working in the hazardous area. After an hour of trying, the contractor was able to escape the room by disassembling the door handle with the limited tools he had on him.

- Make sure workers have a suitable communication device when working on site.
- All doors/locks are being checked to ensure they are working correctly and will be routinely checked as part of Building WOF requirements.
- Take a moment to check the door mechanism is working properly when entering buildings if there is just one exit.
- Report any defects and ensure repairs are completed promptly.
