SAFETY ALERT

The Importance of Prove Test Prove

29th January 2018

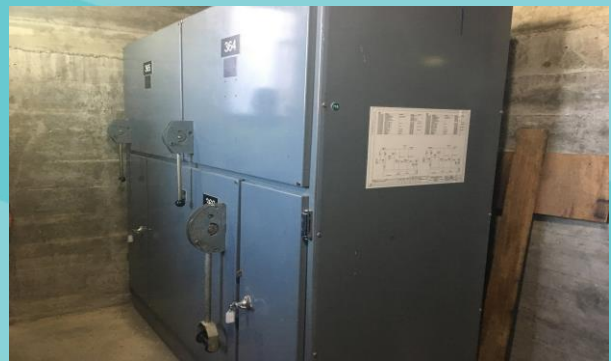
PHOTO:

During January, 3.3kV equipment in the Benmore sluice chamber was scheduled for maintenance. As part of issuer applied safety measures for the permit, the 3.3kV disconnecter switch 369 was confirmed to be open by the normal practice of using the visual indicator on the switch operating handle. The switch was then tagged as part of permit issue. The disconnecter switch contacts cannot be observed directly without partial disassembly of the switch cubicle. The permit recipient then opened the switchboard cubicle and used a voltage detector device (VDD) to check that the equipment under permit was in fact de-energised. Unexpectedly, the VDD indicated the 3.3kV connections were still live and presented a significant hazard to the work area.

During an initial inspection it was observed that the switch mechanism was failing to engage the disconnecter resulting in the circuit to remain live despite the switch colour indicating it was open/isolated.

This near miss has yet again reiterated the importance of Prove Test Prove before undertaking any electrical work.

Further analysis of the switch mechanism is to be undertaken and the root cause outlined in the finalised ICAM investigation.
