**SAFETY
ALERT**

WHERE & WHEN: Huntly Power Station, Unit 6, 5th April 2018

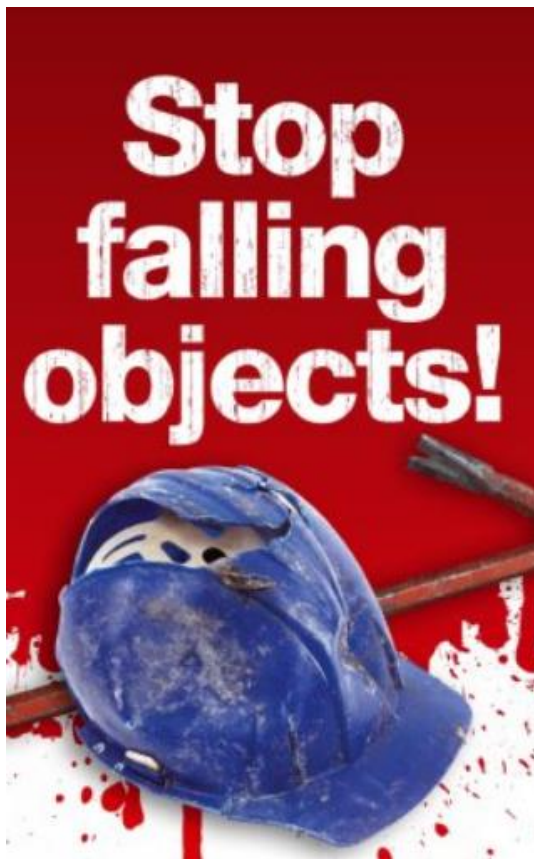
Part of the works identified for the Unit 6 outage this year was the removal the air intake chiller units. Once each chiller module was removed the roof plates were placed back over the exposed hole as a safety measure.

As the job progressed there was a need to clean up the plates before sealing them and bolting them back onto the roof.

When the vibration needle gun was used to clean the plates, the vibration caused the plate to slip off the 20mm flange and fall down onto the filter house floor. Fortunately, this area was vacant as a control that was identified to manage dropped object risks.

Work stopped for Reassessment of hazards.

A new work process was arranged with work party to enable buffing and painting while controlling risk of exposed hole and plate fixing.
