## SAFETY ALERT

**Meter tampering caused voltage to be present on load side terminal.**

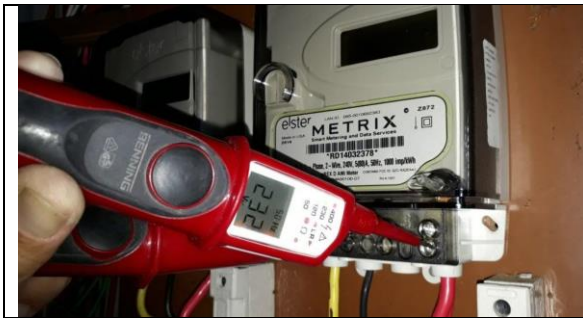
During a site investigation, it was discovered that voltage was present on the load side terminal when the installation was isolated at the master switch. Customer had supplied their unit from another source and supply was back feeding meter. The meter had been remotely disconnected.

Photo demonstrates voltage present on load side when meter line side had been isolated.

- 1) Testing for safety must include testing at the line side and load side of the meter.
- 2) The meter display cannot be relied upon as an indicator of voltage/isolation.

**Always treat conductors as live until testing has proved otherwise.**
