Stop Log Pressure Equalising Valve (PEV) hydraulic pump failed causing unit to rupture

Ohakuri Power Station, Ohakuri Road, Atiamuri,
16/06/2018 – Top of Dam.

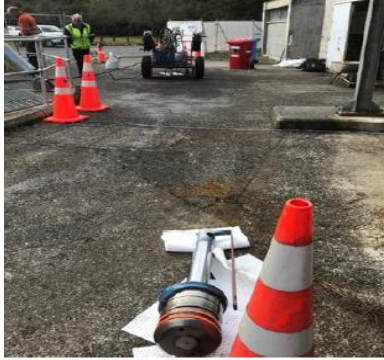
Piston and rod ejected

The piston, rod and cover assembly was ejected forward approximately 11m on the ground. The employee standing next to the pack when it ruptured narrowly missed being hit by the projectile. He was covered in warm oil, but no injury sustained. There was the potential for serious harm or fatality if someone had been standing in front of the unit.

Investigation showed the pressure release valve on the unit had been set to a higher pressure (4000psi) than the unit was capable of sustaining (3000psi max including safety factor). It appears the adjuster on the valve had been adjusted to allow for extra pressure and never reset to the correct setting.

The unit was manufactured of high carbon steel which has low ductility. Constant over pressurisation may have work hardened the material resulting in a sudden fracture.

1. There was no scheduled maintenance for the power pack, due to the irregularity of the use of it. An action was implemented to compile an inventory of all tools, mobile plant, and special equipment with potential high energy source.
2. There was no SOP for the opening and closing of the PEV. A SOP is to be developed for all of the above on a case by case basis.
3. All tools, mobile plant, and special equipment with potential high energy source are to be captured in maximo so that a PM can be generated to inspect them on a regular basis.
4. All existing hydraulic systems both portable and fixed need to be checked to ensure they have correct fittings for hydraulic service.
5. A new power pack is to be designed encompassing safety in design and ensuring it is fit for purpose.

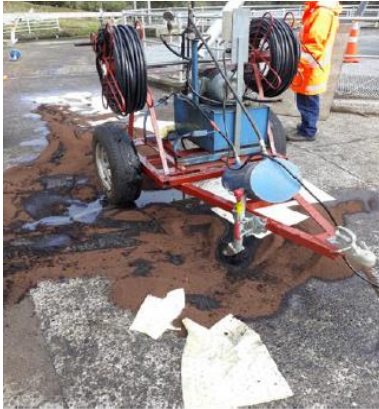
Mimic Hydraulic system with piston and rod in background
