**SAFETY
ALERT**

WHERE & WHEN: Huntly Unit Two Outage - 14 January 2019

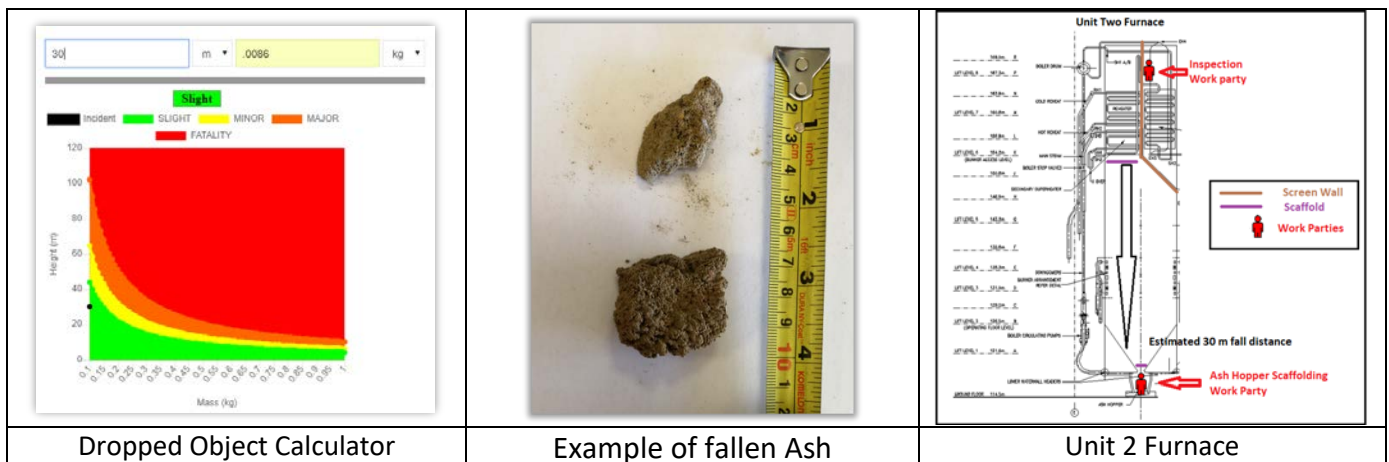
A work party, in the U2 Furnace ash hopper, had lumps of furnace ash fall on them from above. A second work party was working above the ash hopper work party inspecting the furnace back pass tubes. It is thought that the movement of the inspection work party walking on the tubes resulted in ash falling off the tubes in the furnace area above the Ash Hopper work party. A stop work meeting was held by all parties and respective management and the inspection work was postponed until the Ash Hopper work party had finished.

Dropped Object Calculator

Example of fallen Ash

Unit 2 Furnace

- Recommend Working at Height template JSA for furnace inspection to include control of risk of falling objects.
- Recommend Work at Height Policy to include not working above another work party.
