SAFETY ALERT

Air Pressure Regulator Blowout

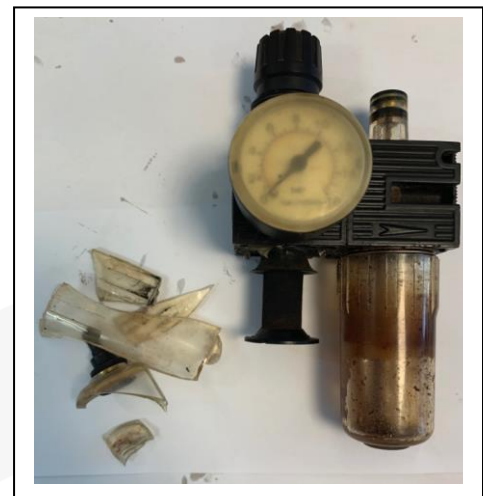
Oil was being transferred from 40 gallon drums to a larger storage tank using a Wilden pump. The Wilden pump was turned off to switch between drums. A loud bang was heard and on investigation the plastic air pressure regulator bowl was found to be blown out and in bits.

The Air Pressure regulator is exposed to the elements which would have played a part in weakening the bowl allowing pressure to shatter bowl.

Bowls exposed to UV light & outdoor conditions have an increased chance of fragility.

Inspections of Air Pressure Regulators exposed to UV light & outdoor conditions, look at changing to an outer plastic protection casing for bowls exposed to UV and outdoor conditions.
