SAFETY ALERT

2" Air hose burst

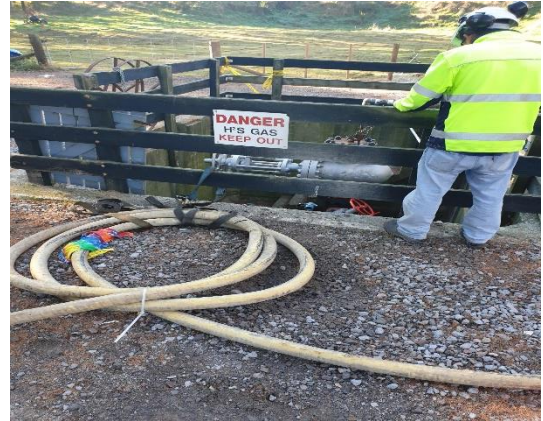
During an Air Cap job while pressurising Well, pressure had been raised in increments of 5 Bar holding for a period 15mins with steps repeated till a final pressure of 25 bar was to be reached. Pressure reached approximately 24 bar when off sider noticed bulge in hose so proceeded to shut down compressor unit, before reaching stop button, hose burst causing a loud noise and a creating a cavity in the underlying gravel.

The 600psi rated hose was certified, it had been visually checked for damage, had secondary retention and hose was restrained to surrounding barrier at 2 points.

Hose had been pressure tested at 26.7 bar (387psi) and held for 10 minutes prior to pressurising Well.

Possible causes could be damage beneath protection layer of hose or a manufacture defect in hose.

If all practicable steps are taken to avoid an incident with good procedures and great planning we can "**Fail Safely**"

No one was injured, PPE requirements adhered to.
