Incident Title:

Access to LV of kiosk while energised

Wednesday 27th June 2018

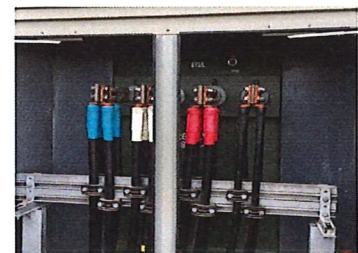
The BoP operator proceeded to unlock the LV 690v double doors of a TX Kiosk and then stood back, took a photo of the bushing, closed the double doors and locked the LV door.

Signage in the LV area states that the LV doors must not be opened unless transformer has been isolated and earthed, this was not followed.

Double access doors with locks

Correct operating procedures and signage need to be followed always.

If there is any doubt or if unsure about the task STOP Take 5 and contact your supervisor for clarification.
