Removable Tow Bar Tongue failure

Hydro Site

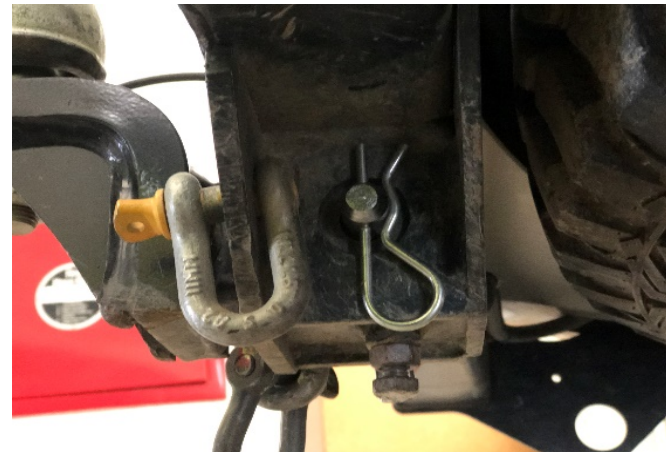
We were in the process of launching a Jet boat for an inspection of flushing operations in a Hydro lake. During retrieval of the empty boat trailer at the boat ramp, the removable towing tongue disengaged from the vehicle tow bar causing the trailer to fall to the ground. The trailer was still attached by the safety chain.

This tow bar arrangement is standard for many vehicles these days. The tow bar has a removable tongue held in by a pin and an R clip to hold the pin in place. This vehicle is regularly used off road and the tow bar end of the vehicle can often contact vegetation or scrape on the ground. This may be a factor in the R clip coming off and the main pin falling out.

What did we learn?
The R clip isn't the most secure arrangement for locking the pin in place.
When fitting a trailer always check the integrity of the towing set up.
Always ensure the safety chain is securely attached.

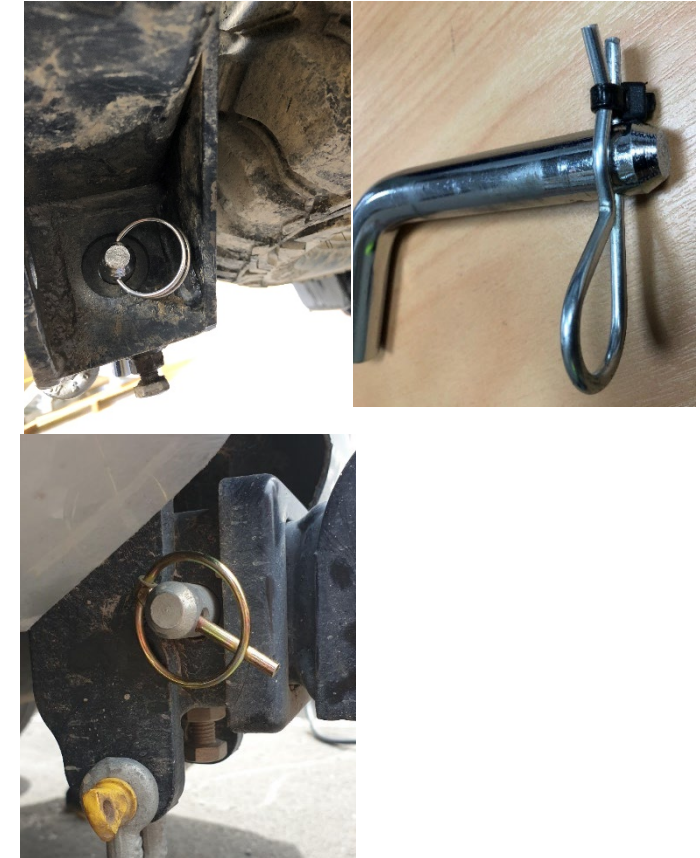
Here are some improvement suggestions:
