Live feeder cable cut in disconnection error

Christchurch – residential home.

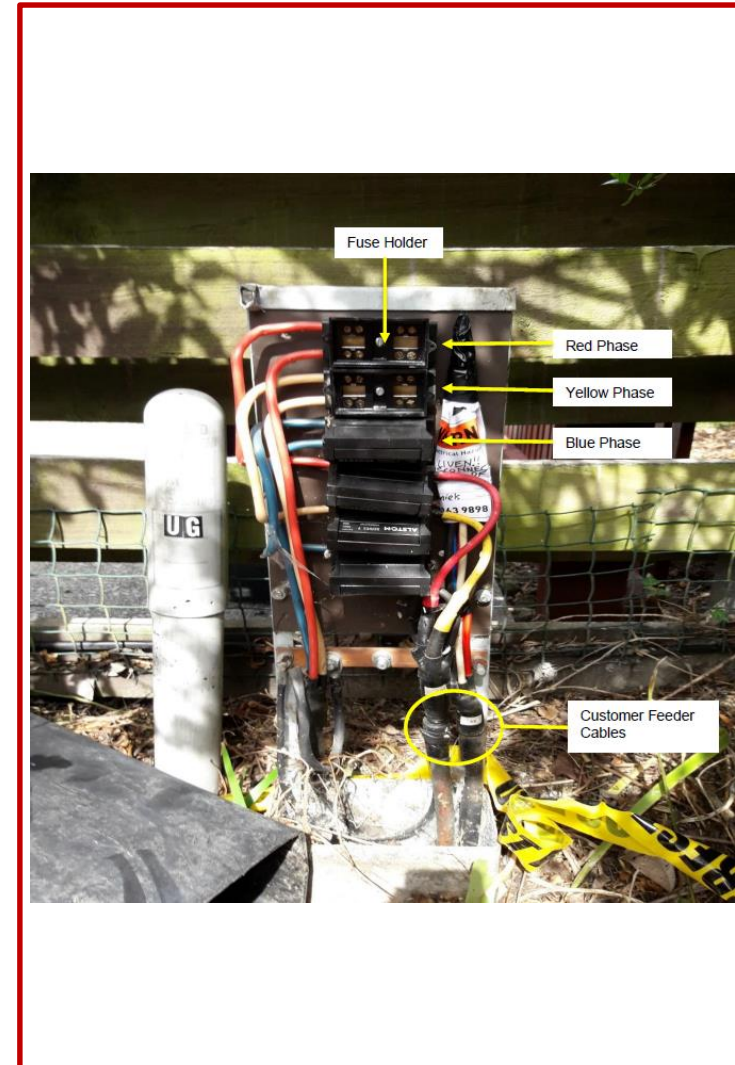
The disconnection wasn't completed correctly. There were three phases going from the network to the pillar box which then supplied two properties. The supply cables were colour coded and the feeder cables marked. The technician only disconnected one of the phases leaving the property partially connected.

There was no testing undertaken to verify the disconnection.

There was no test undertaken by the demolition contractor to confirm the cable was dead.
