Changed location – risk assessment

Hydro Generation Site

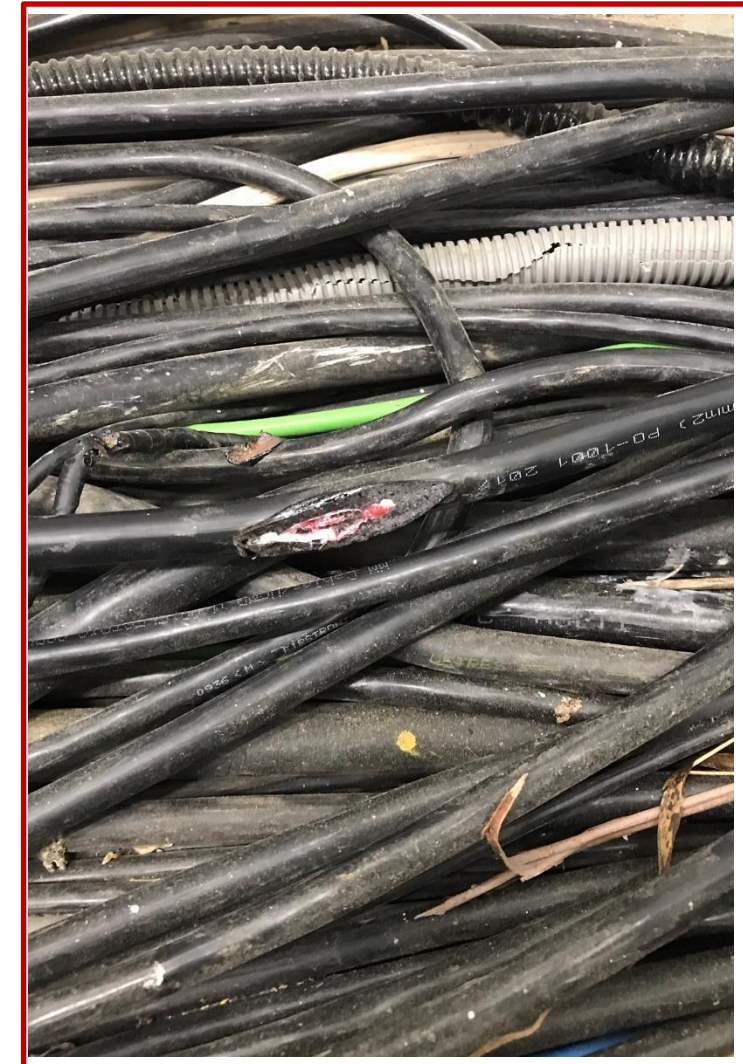
Following use of an LPG heating nozzle to heat and remove a bearing Thrust Retaining Collar the LPG nozzle was placed in the holder on the gas set, to cool. Sometime after, the nozzle has slipped forward from the holder onto exposed cables in a cable tray. After checking the nozzle for voltage and removing it made safe the damaged cable by wrapping with self-amalgamating tape / Electrical insulation putty) and then wrapping in insulation tape.

Consider the surrounding environment when relocating any objects to ensure the new location does not present a risk of harm.

During or following major works, review changes made to surrounding area and ensure no hazards have been introduced and any safety systems or risk mitigation have been re-instated.

If using heat sources, ensure that once work is complete all equipment is allowed to cool in a safe manner and no residual heat remains.
