### Isolation Integrity

### Hydro Generation Site

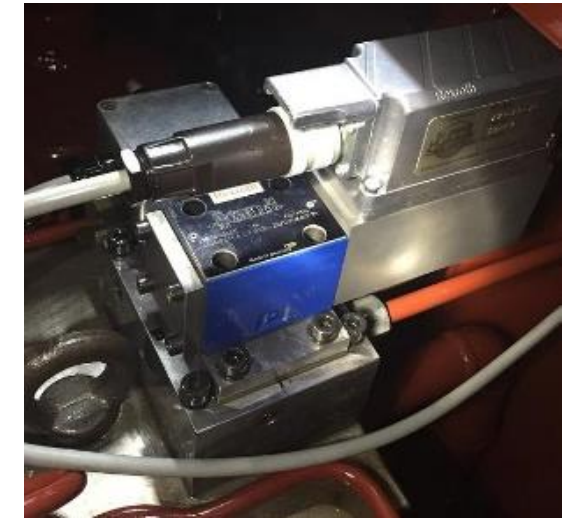
A worker had isolated a pressurised hydraulic fluid line, dissipating the pressure by operating the hydraulic circuit. He then proceeded to loosen a solenoid before removing. There was no release of hydraulic fluid after initially loosening the solenoid attachment and this was taken as an indication that the system was indeed depressurised.

Moments later a steady stream of hydraulic fluid escaped from the joining faces of this component releasing an oil vapour into the room. The worker was partially guarded by the large box housing the hydraulic components, however did have his upper body coated in the substance. Fire alarms were also tripped by the occurrence.

It appears an o-ring used to seal the joint, maintained the seal for a moment before succumbing to the pressure within the line. Upon investigation it was found that the valve used for isolation was faulty. The worker was repeating what was considered an accepted procedure within the plant and believed he had accurately isolated the line and proven it depressurised.

- The most effective way to prove a line is depressurised is with an in-line pressure gauge using the test-prove-test method
- A control valve should not be used as an isolation valve for any pressurised systems
- An isolation valve that looks closed, may in fact not be

- In all instances, if you cannot demonstrate that your isolations are effective before commencing work, in a manner that does not put yourself or others at risk of harm, further steps must be taken to drain or de-pressurise the entire system upstream of the isolation
