Incorrect body positioning – Broken Leg

Aratiatia Screen Cleaner

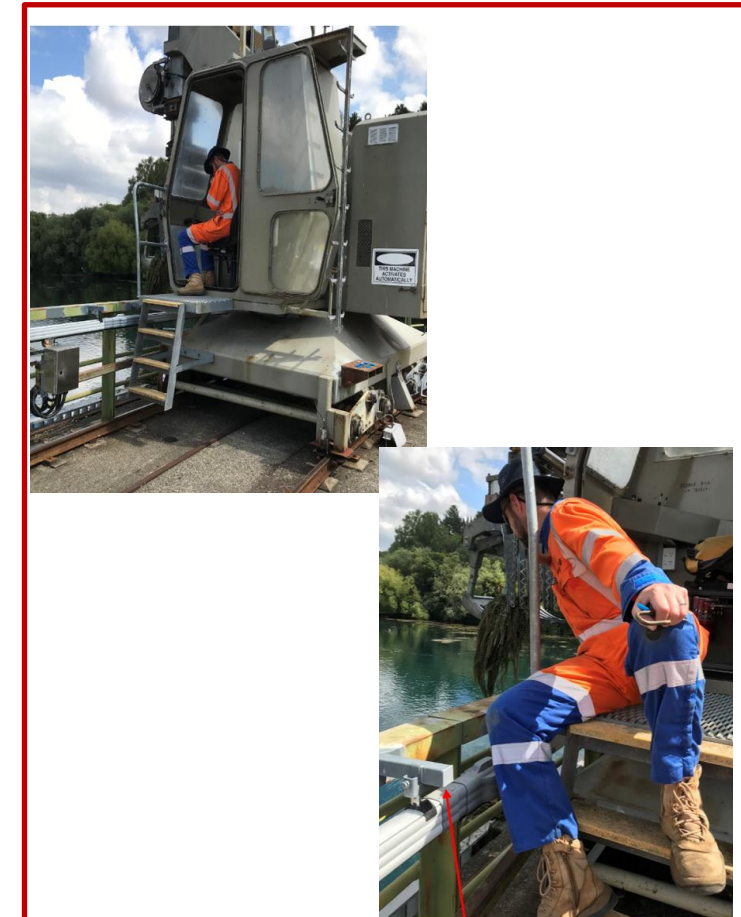
The machine was traversing left while he and the operator were looking in the opposite direction and the position of his body forced his leg outside of the platform he was sitting on, resulting it being crushed between the fence railing and the platform when the screen cleaner moved.

Simulation of sitting position whilst sitting on step and fence bracket which impacts below the right knee

1. The Injured party chose to sit on the platform to escape the hot sun, he was wearing CAL 12 PPE. We will review the use of heavy PPE in summer months.
2. It is Important for all staff to be vigilant and assess risks and hazards when they engage in practices which would not be considered "normal"
3. The methodology for cleaning weed from the screens during manual operation will be reviewed for improvements.
4. The Safety barriers and guarding on this screen cleaner need upgrading.
5. The Perspex cab windows were brittle and yellow, offering poor visibility out of the cab.
