Fall from height

Hydro Scheme

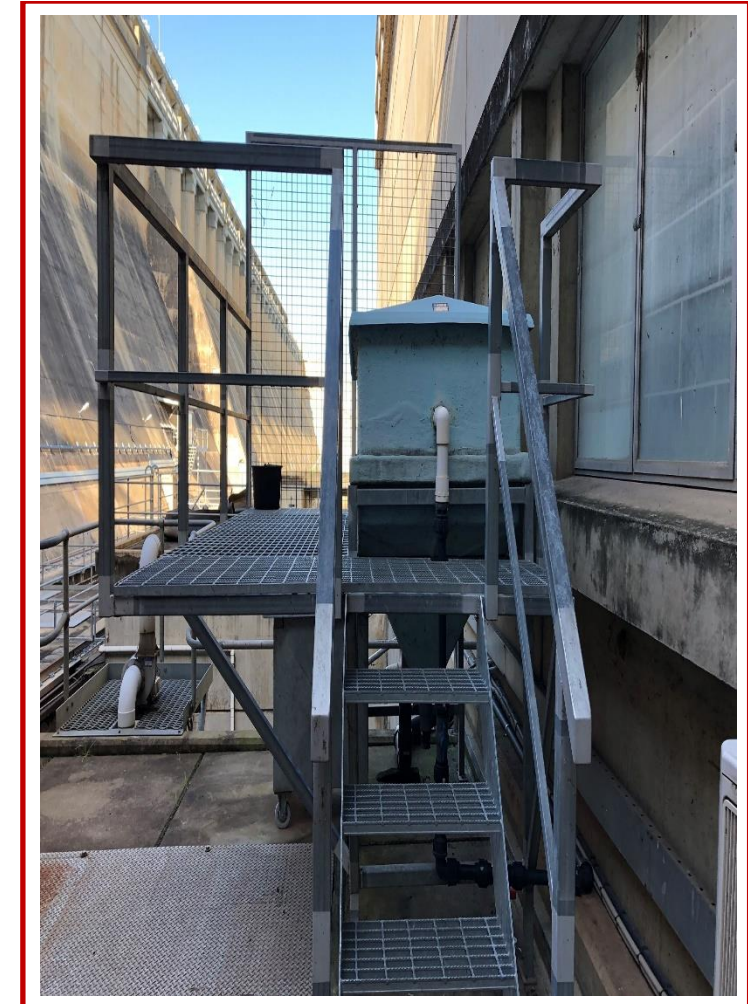
Two contractors were involved in a near miss when a recently decommissioned oil separator tipped over while removing waste oil from the unit.

The decommissioned separator had been removed from its installed location and hold down bolts.

The separator has a canter levered walkway along one side that was initially stable due to the volume of oily water in the tank. However, the platform that the contractors were standing on became unstable as they removed the wastewater that was acting as ballast and it tilted over.

Unfortunately, this instability caused one of the workers to fall approximately 900mm from the platform to the concrete floor, thankfully though, the worker was not harmed during the incident.

Benefits of performing a site safety stand down immediately after incident.

Benefits of a cross-discipline approach to WSSP/task development.

Fast track Temporary Hazard board which has been stuck in Melbourne due to COVID-19.

Importance of using the Temporary Hazard Board to capture risks.

Awareness that de-commissioned equipment presents different risks than when in service.
