SAFETY ALERT

Shared Learnings

Lost Trailer Tailgate

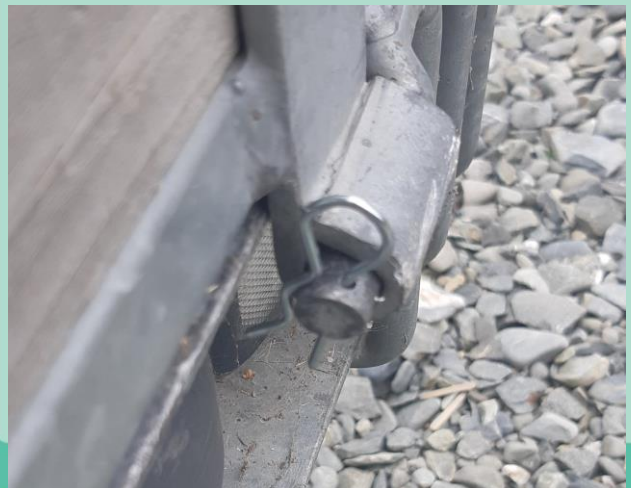
PHOTO:

The trailer tailgate had no pin in the hinge mechanism to prevent the tailgate moving sideways and falling off trailer when in the open position.

Removable hinge pin locking R-clips have since been installed as per the attached photo

All trailers should have a mechanism in the hinge to prevent the tailgate from falling off when open.

Please inspect all trailers to ensure some form of retaining mechanism is fitted to the hinges to prevent a reoccurrence of the tailgate incident.
