## Incorrect Use of Emergency Showers

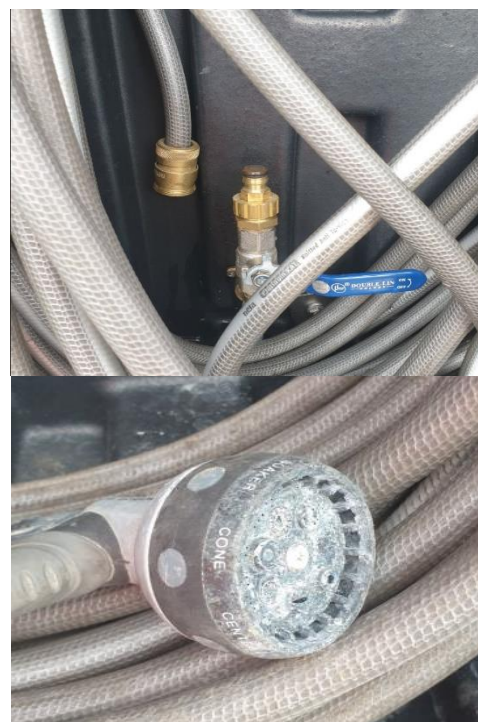
While undertaking site inspections it was found that a number of emergency showers were missing their anti-tamper devices (plastic ties). On closer inspection a combination of the following issues were also observed:

- The shower nozzle and hose contained foreign (dry dirt) residue or was damaged.
- The multi-mode shower nozzle was in “Jet” mode and not “Shower” mode as required.
- The hose was not attached to the water supply.
- The Spray nozzle had been removed from hose and located elsewhere on site.

- Shower nozzles were cleaned and repaired.
- The hoses were properly coiled and stored to ensure there were no kinks to stop water flow.
- Shower nozzles were turned to the correct “Shower” mode. When treating burns “Jet” mode could cause permanent damage to the user.
- Shower cabinets were closed and fitted with new anti-tamper device.

- Investigate installing an alarm system in conjunction with anti-tamper device
- Review stations SMP’s to ensure these are monitored more frequently
- Review usage of multi-mode nozzle and replace if needed
- Ensure near miss incidents are entered into Maximo for each time found at a site.
