Shared Learning

Mobile plant and equipment | sub fell off during transport | Geothermal site

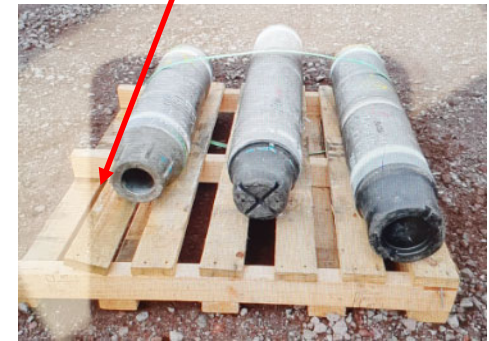
- Due to the way the 'load choker' was routed, upward force has been placed on one of the pallet's planks. This plank has dislodged after three hours of driving, resulting in the stop loosening slightly, and allowing the sub to fall off the pallet.
- Going forward look to secure on steel pallets or to a cradle within a basket

Lifted pallet rung releasing tension
