Unauthorised Removal of Isolations

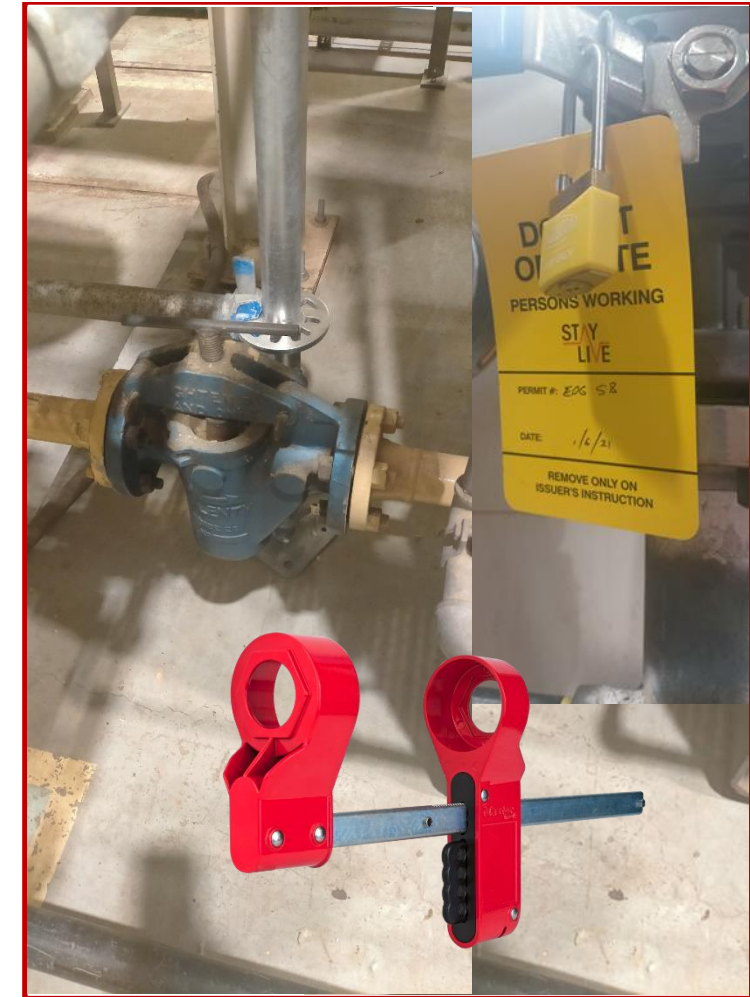
Blind flanges or spades should be locked not just tagged. The blind flanges should have been Locked and Tagged with the use of a flange lockout device (pictured). The incident may not have occurred as the key to the lock would have had to be retrieved from a permit issuer controlled lockbox. The familiarity of other Work Control Procedures in place at the site may have contributed to the incident. Further training by way of toolbox talks took place to ensure workers understood the importance of adhering to the work control procedures.
