Embedded nail into Thumb from nail gun

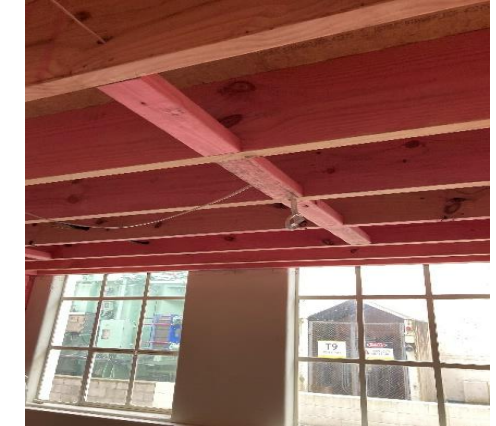
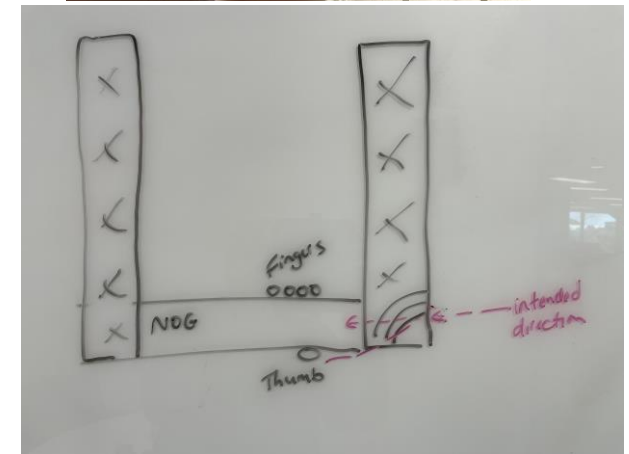
During the construction of an office refurbishment the builder was nailing timber framing with a nail gun. The nail glanced off the timber which had hardened “rings” at the junction which deflected the nail downwards and into his thumb.

IP was taken for medical treatment with the nail still embedded into the thumb. The thumb was x-rayed and the nail removed.

The reason the nail had deflected off the corner of the wood was because the wood had “rings” due to the ageing. This results in the wood hardening, which can easily deflect a nail fired from a nail gun.

Good practice is to ensure care is taken around wood selection so that no rings or wood knots are near where joints are being nailed, even if this results in some wood wastage.
