Medical Treatment Injury whilst using Drill Press

Karapiro Hydro Station - Mercury

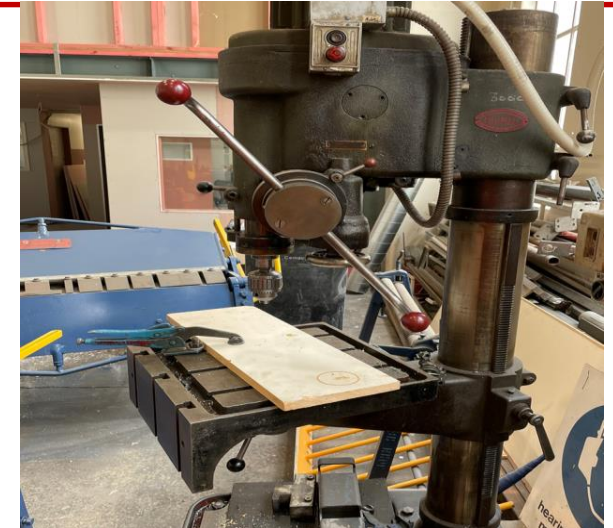
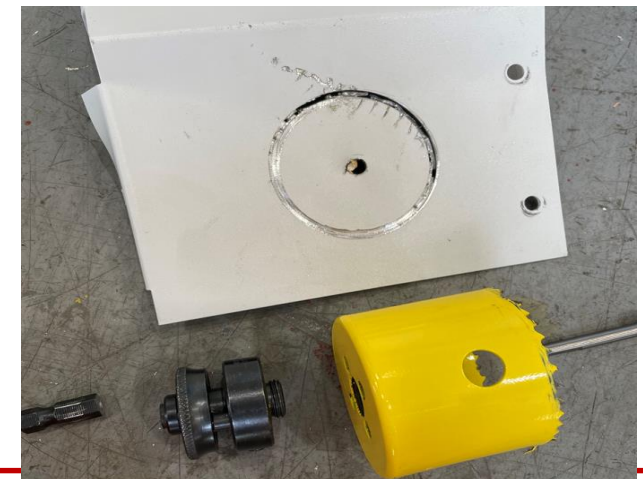
1. The IP (injured party) was using the drill press at the Station mechanical workshop to drill cable plates for a new 400v cabinet.
2. The IP didn't clamp the plate to the drill press resulting in it spinning around whilst drilling
3. The edge of the metal plate caught the IP on the hand and finger, resulting in 5 stitches.

1. Checks are necessary to ensure workers are competent and not just trained in using specialised equipment.
2. A Safe Work Procedure attached to the machine may have ensured that the clamping of the metal plate occurred prior any drilling taking place
3. Pre-start meetings need to include discussions around specialised equipment and competency.
4. Anything being drilled will be clamped securely in place
