### Lost time injury whilst inspecting ventilation fan

### Whakamaru Hydro Station - Mercury

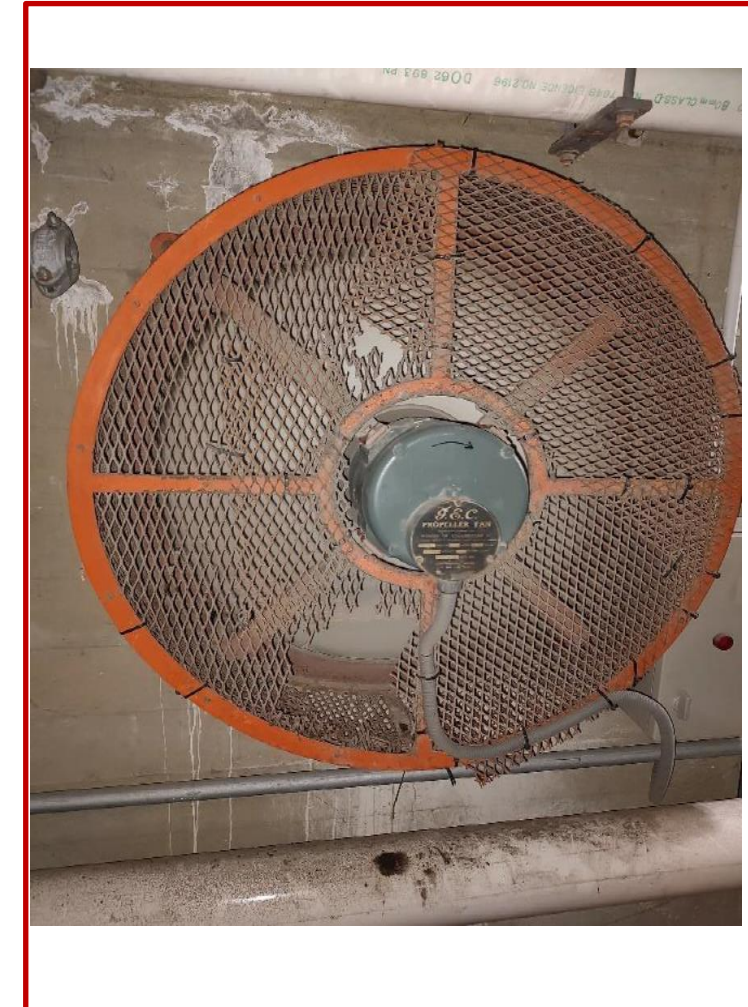
1. The IP (injured party) was inspecting the ventilation fan for thermographic records.
2. The fan grill was in poor condition, and in a cable gallery not often frequented. A Work Order had previously been raised for repair this had not been actioned.
3. The IP noticed the fan vibrating more than it should be and in an effort to identify the source of a vibration the IP placed their hand on the grill to “feel” the vibration
4. As a result the IP’s hand went through the hole in the mesh resulting in cut hand and fingers.
5. This resulted in stitches to the IP and lost time.

1. Personnel on site were aware of the condition of the fan, but had previously “walked past it” as a WO was in place and it wasn’t deemed “urgent”

1. The fan repairs were actioned immediately.
2. A guarding review was conducted across all sites with a recommendations for any similar repairs or upgrades identified.
3. A review of all aging Work Orders was conducted. Consideration or re-prioritising any work that could later result in a more serious outcome was actioned.
