Wheel Loader Rollover

Wind Asset

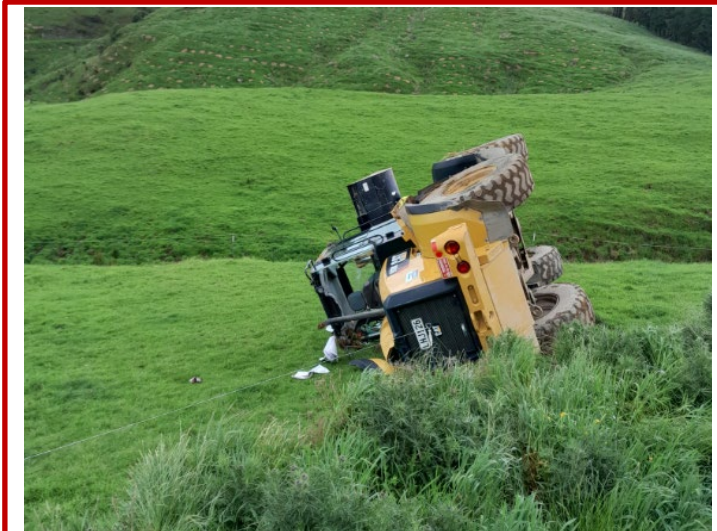
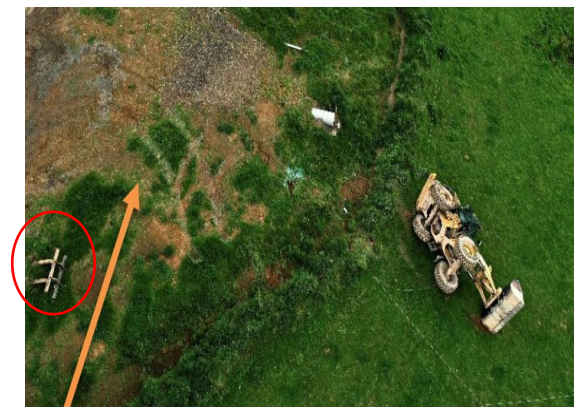
While looping around to reposition the loader on a slope the wheel loader lost traction and rolled sideways approximately 1.5 times coming to rest on its side.

Aerial pic of the path of the loader attempting to come around and beneath the forks to pick them up.

An established stockpile was used as a car park, *this contributed to a poor decision to work in an area that was not set up as a recognised stockpile with bunding.*
