Lead paint found on generator while grinding

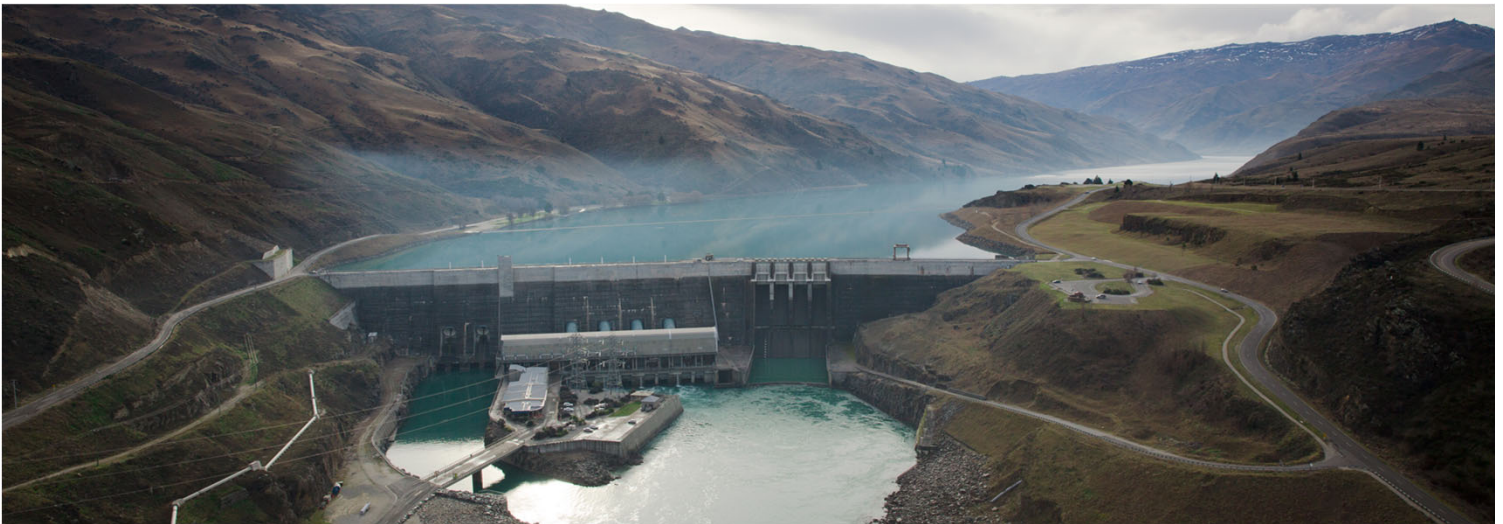
An employee who was performing grinding work on a generator rotor came across lead paint whilst grinding. It was with luck and due to a personal decision, he was wearing an air-fed mask - this was not an identified control.

Engineers expressed that the lead paint is not only present on the rotor, but that it is likely on other parts of the generator and other areas of the machines.

- Attaching the manufacturers hazard documentation to the area's functional location where we know its present (in SAP). That would automatically produce the hazard document in the work packs.
- Sticking QR code labels onto the machine itself where the hazard is present to link that back to the manufacturer's documents.
