# Safety alert

## Volatile Rust Inhibitor – Present in Steam Gland Pipes

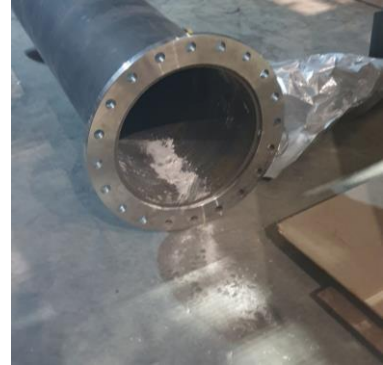
Contractor was welding a flange onto a steam gland pipe when a powdery white substance inside a pipe has ignited.

A white flame has resulted, contractor had hot work controls in-situ and it was extinguished immediately by the welder.

The substance has turned out to be a Volatile Rust Inhibitor that is applied into the pipe at the point of manufacture in Japan.

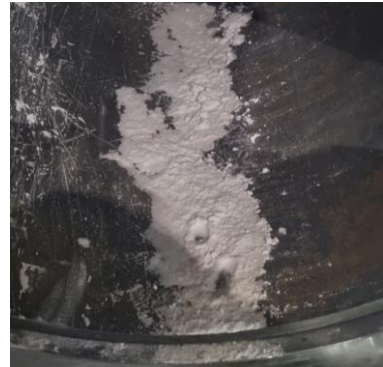
Volatile Rust Inhibitor (VP-1, Dicyclohexylammonium Nitrite) is a combustible material applied to pipes/fitting prior to shipping.

The welding in close proximity provided an ignition source.

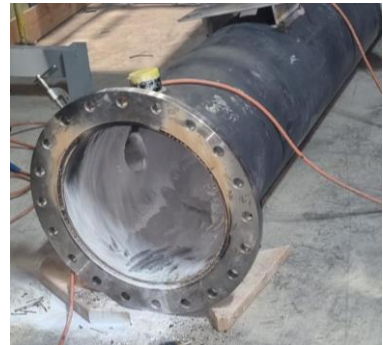
VP-1 is used in some pipe/fittings coming from overseas to prevent moisture build up from shipping.

The flame has a white flare like intensity – which adds strength to it being a chemical reaction/burn.

If white powdery substance found in pipe, clean the end of the pipe via cloth or wire brush using appropriate respiratory protection, allow pipe to self ventilate.

Have controls in place regarding hot works, adequate PPE in regards to potential fumes, exclusion zones while welding.

Procurement to be aware of pipe/fittings being coated in this going forward.

Inspect pipes for white powdery substance prior to hot works.
