### Digging Around Damaged 11kV Cable.

### Hydro Asset

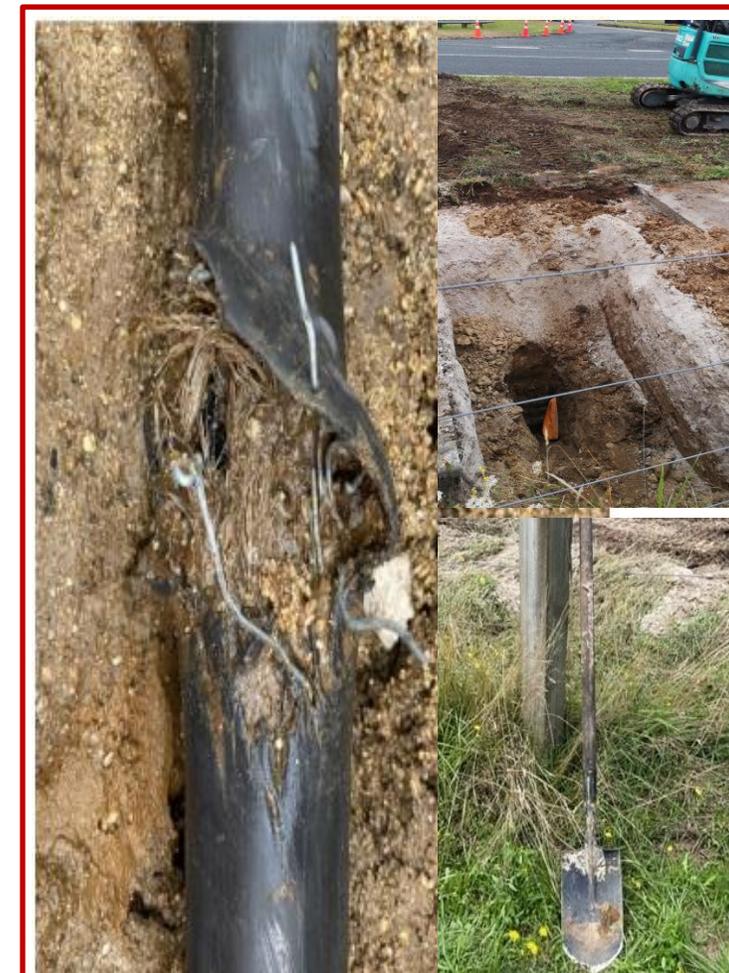
1. A contractor struck and damaged an 11KV cable whilst directional drilling. One phase of the cable was damaged and as such only one of the DDO fuses operated.
2. The remaining two live phases of the cable had the potential to back feed the damage phase through the HV windings of the attached 11KV/400V transformer.
3. The contractor dug around the damaged cable with a digger and then with a shovel.
4. Had the contractor touched the damaged phase of the cable with the shovel this may have been a significant injury or fatality incident.

1. Stopping the work did not occur after the incident.
2. No awareness of the perceived danger posed by the damaged 11KV cable.

1. Highlight to the contractor and staff the importance of Stopping Work and notifying the asset owner immediately when an incident occurs or works procedures significantly change.
2. Highlight to the contractor and staff the significant dangers posed by un isolated, unearthed electrical equipment.

**“Treat all electrical equipment as live until visibly isolated and earthed”.**
