# Shared Learning

Uncontrolled release of water under pressure | Tongariro Power Scheme

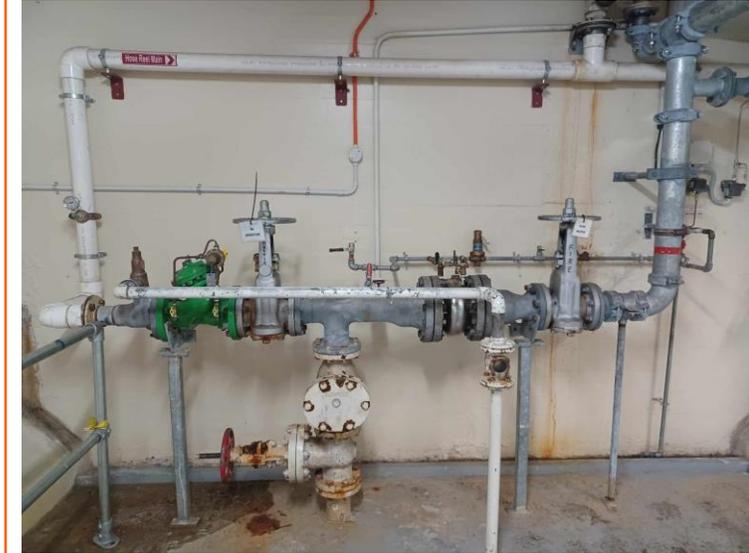
Defect work to service the Fire System Pressure Relief Valve (PRV) and Pressure Regulating Valves (sometimes also referred to as PRV) which required removing the valves from service. Work Authority issued but the appropriate RASM's were not in place for the Pressure Regulating Valve resulting in a sudden release of pressurised water (20 bar).

- The term 'PRV' has multiple meanings and created confusion around which valve was meant to be worked on.
- Labelling of these valves needs to be improved
- Clearer communication is required between issuer and recipient around work methodology for the task
- Investigation / scoping process of this work could have involved operations/issuer to confirm system status and isolation's with relevant drawings to give the maintainer a better understanding.
