Shared Learning

Dropped Objects | Rotten scaffold plank edge allowed spanner to fall through

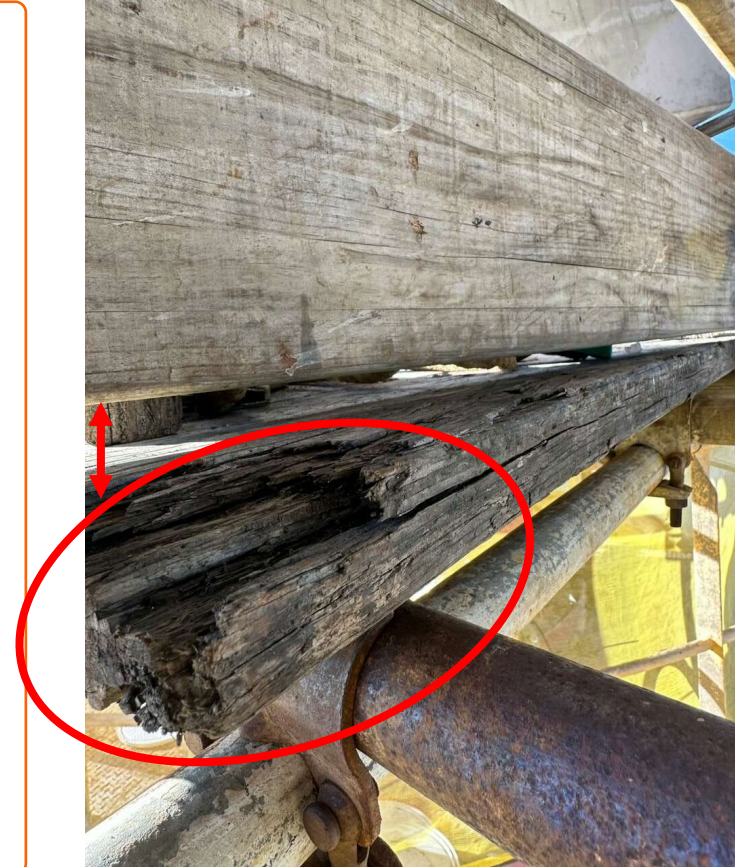
Whilst undertaking maintenance work from an approved and ticketed scaffold, a spanner was kicked backwards, slipping under a kickboard and falling through a damaged scaffold plank. The plank was rotten on the edge and the kickboard was 40mm above the plank at the far end (not installed level).

The damaged plank forming part of this scaffold had not been picked up during the sign off and not found during prestart checks by the maintenance crew.

The spanner fell 5m to the ground below.

All other scaffolds checked immediately for compliance.

It is commonplace to check scaffolds for compliance by finding the safety tag signed off by an appropriate supervisor based on trust and experience of that supervisor. There have been times where damaged or rusty equipment has still been used either from complacency or modifications within the scaffold that has not prompted another supervisor check. Maintenance crews should undertake additional checks on their work areas to ensure all equipment is intact and report any damages they see.

Additionally, even when working from a relatively secure platform at height, it still pays to have lanyards on tools to cover all eventualities
