# **Safety Alert**

## Switchboard earth closed into live 11kV busbar

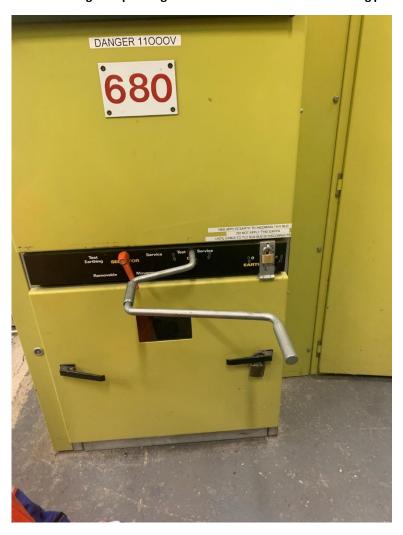
CB680 showing the operating handle inserted on the normal racking position.

- No OEM or site operating procedures were available on site at the time for this switchboard.
- The operating order was being developed during the switching activity. Operating orders should be
  developed at least 24 hours in advance through review of the required work activity, H.V single line
  diagrams (SLD), OEM manuals, review of previous operating orders etc before being checked by a
  second competent person and approved for actioning on site. This may include a simulation of the
  steps to ensure they are correct.

- The design of the switchboard in this scenario does not prevent inadvertent application of the equipment earth, this means that compiling and checking the operating order is correct is essential for safe switching.

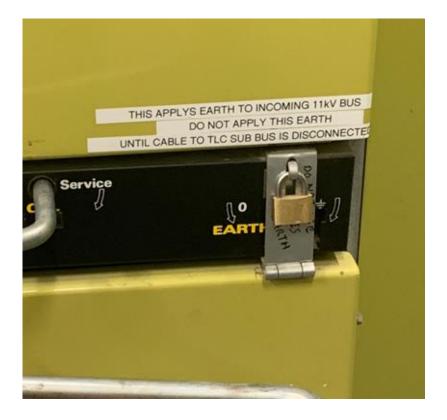
Temporary warning label applied to the switchboard earthing handle insertion point

- There was a lack of information available for the circuit breakers and switchboard (e.g., no warning sign at the earthing application point or electrical diagram show earthing connection design). Check these are visible and available when planning work.

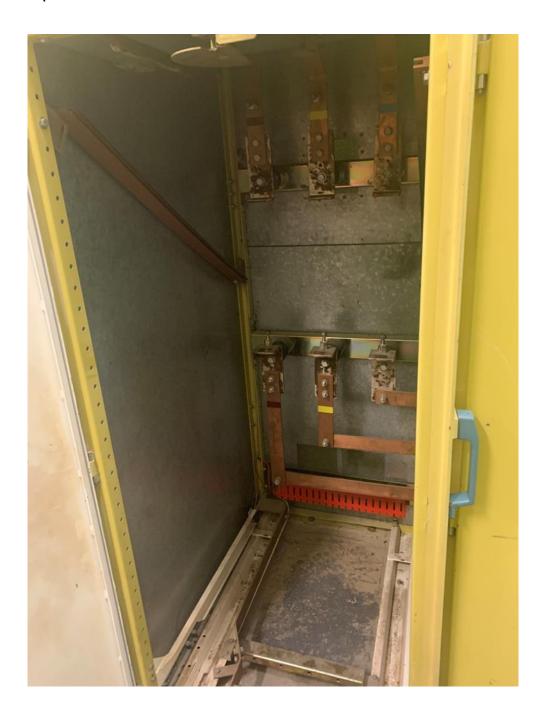
#### Unprotected 11kV bus

- The switchboard does not have any bus shutters or OEM means of inadvertent contact prevention with live 11kV bus when circuit breaker 1212 is removed from the cubical. Any such situation requires that the cubical door is immediately locked closed with an issuer applied safety measure (IASM) lock.
