Safety alert

Casing Dropped to ground while to be unloaded from Truck

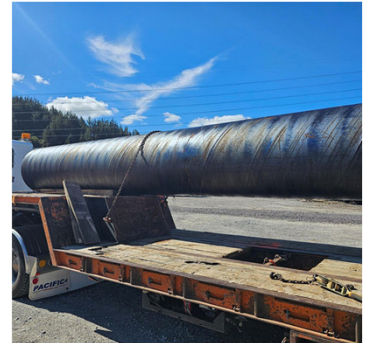
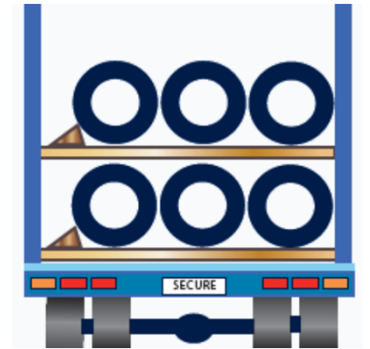
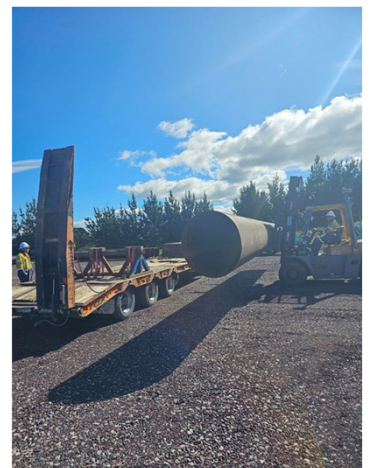
Casing for geothermal well (42" diameter x 12m long x 3 tons) dropped to ground by about a metre while to be unloaded from truck.

The trucking contractor had used chocks to secure the casing in place. Chains were also used. These chocks were insufficient to arrest the casing when chains were removed during unloading at the pad. The casing crushed the chocks and rolled off the truck.

This was not adhered to or discussed with the parties prior to or during the job. Most notable non-compliance: there were no stanchions installed on truck.

Only engage preferred Contractor as they are well versed & strictly adhering to CEL Casing Transport Policy.

Urgent engagement with short notice (which was a factor in choosing the truck) can be avoided with organized planning.
