# Safety alert

## Minor Electric Shock while using a Portable Grinder

Minor Electric shock received while using a portable electric grinder.

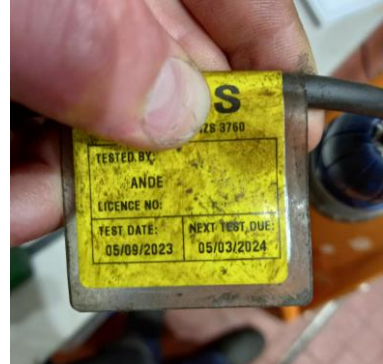
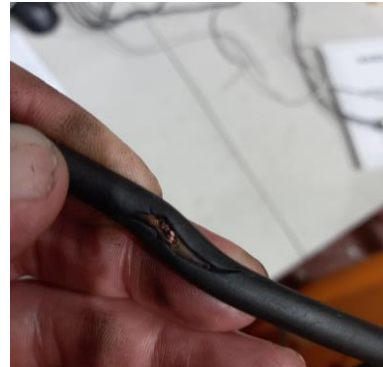
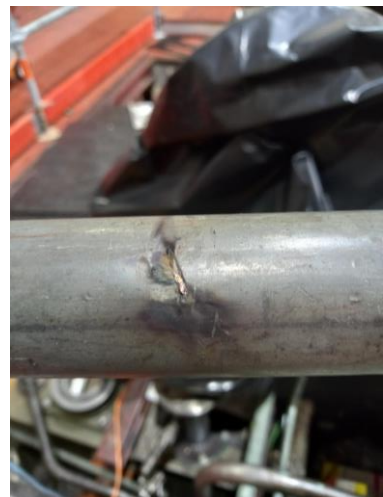
A Contractor was using a tagged grinder to buff the turbine casing half joint. When he had finished, he pulled the grinder lead towards himself. The lead was draped over a scaffold, and he received a minor electric shock. On inspection a small section of the grinder electrical lead was found to have exposed wiring, the exposed conductor appears to have made contact with the scaffold.

This particular electrical device was double insulated, meaning that protection from serious electric shock is provided by adding an additional layer of insulation, and removing the requirement for a protective earthing conductor.

Although an RCD (Residual Current Device) should be used where possible, they do not eliminate the risk of electric shock. An RCD provides added safety by monitoring any leakage between phase and earthing connection. In this instance the RCD did not provide protection as double insulated power tools do not have a earthing connection.

Always check your power cords and appliances for damage before using them.

Promote the use of Battery-Operated Grinders & tools (this brings additional housekeeping requirements for safe battery charging).

Identification of Electricity Hazards in general for work parties.
