Shared Learning

Flammable Gas | Hydrogen release while carrying out condenser repair works | Kawerau site

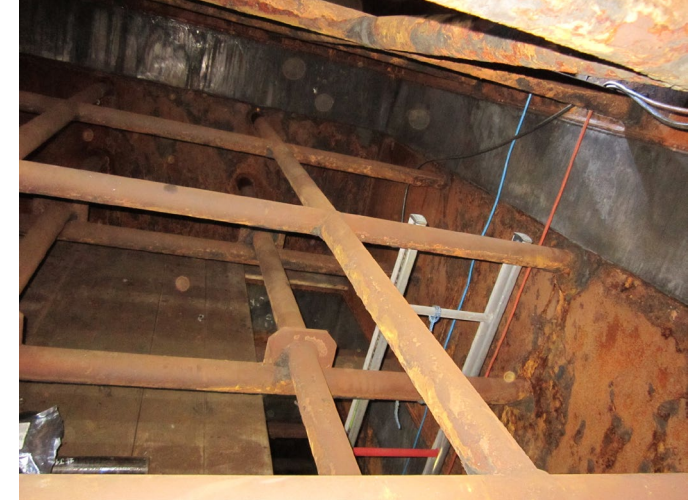
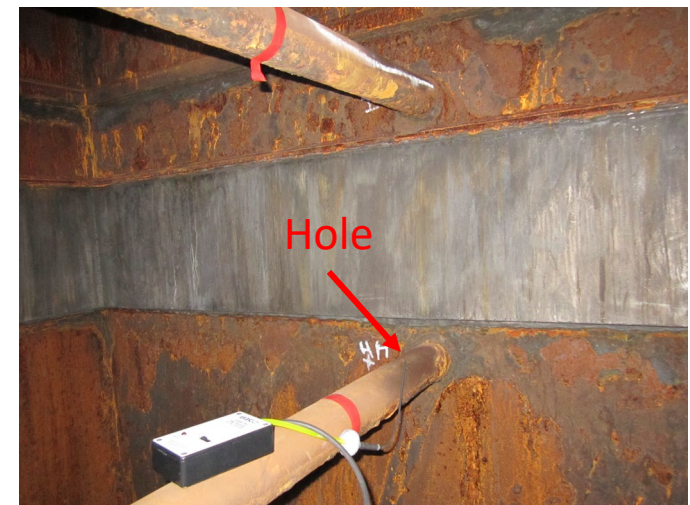
The incident investigation identified the formation of hydrogen inside the stay bars as the root cause of the pressure build up.

- External corrosion of the carbon steel stay bar tubing generates atomic hydrogen
- Normally the atomic hydrogen combines to form H₂ which blows away or dissolves, but
- Hydrogen sulphide, present in geothermal steam, is a “cathodic poison” which causes the atomic hydrogen to instead diffuse into the steel
- Hydrogen atoms which diffuse to the void inside of the pipe recombine to form H₂
- The pressure which can be generated is extremely high
- The CO gas detector was confirmed to be cross sensitive to hydrogen explaining the CO gas detector alarm

The team is currently assessing methods to measure the internal pressure and / or depressurise the condenser stay bars, including options for redesign.

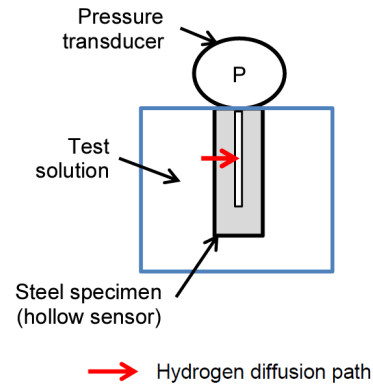
The hollow stay bars resemble the experimental set up to measure hydrogen permeation through steel, the so-called 'hollow sensor' method, hence confirming the hydrogen diffusion and pressure build up mechanism. Sources: "Evaluation of the Interactions Between Hydrogen and Steel in Geothermal Conditions with H₂S", J. Kittel et al. 2021. "Hydrogen in steel exposed to geothermal fluid", G. McAdam et al. 1981.

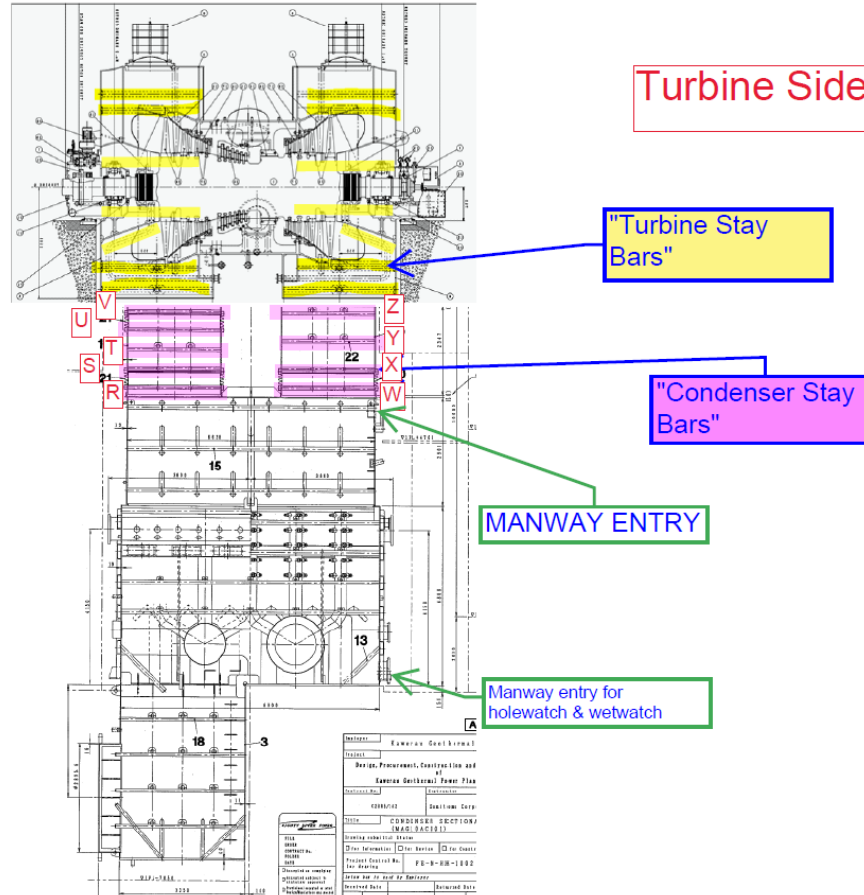
On 17 May 2023, while preparing for cut out and replacement of some of the welded hollow structural tubing of the turbine condenser at the Mercury Kawerau geothermal power station, a contractor drilled a hole to check the atmosphere inside the tubing. Once the tube wall was breached there was a sudden release of pressure. Within seconds of this release, a gas detector detected 72 ppm CO.

Generator Side

Turbine Side
