SAFETY ALERT

Outline the Scene	Incident	Roller Slip on Hardfill Batter
	Incident Date	November 2nd 2024
	Business Unit	HBCC

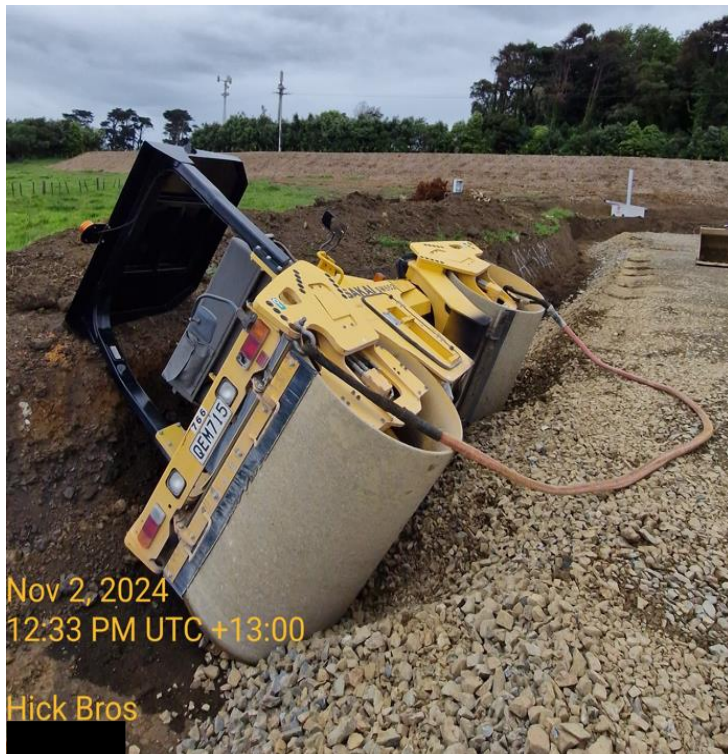
While compacting hardfill using a 12t twin drum roller, a HBCC Operator (C3) drove parallel to the edge/batter of the pad subsequently causing the roller to slip and tip into the bund adjacent. Prior to the incident, the operator had been following the safe work practice of approaching the batter 90° to the face. In attempting to make good some ridges formed by the drums, they switched to unsafely compacting parallel to the face. Under the vibration & weight of the roller, the ground began to shift, and the roller slowly slid downwards before coming to a stop on the bund. The operator was unaware of the E-Stop function on the roller which may have prevented the slip. Luckily the operator was wearing a seat belt and remained in place while being protected by the ROPS.

This is a firm reminder of why we wear a seatbelt when operating mobile plant! Without wearing a seatbelt, this operator may have suffered a life altering injury.

- 1) Are you trained & authorised to operate the plant assigned?
- 2) Is there an approved Safe System of Work in place for the assigned task? – SWMS / TA / SOP
- 3) Are you aware of the Hazards & Risks? - 5x5
- 4) Are you aware of the E-Stop function on site plant?
