Preventing Distribution Transformer Bushings Gasket Erosion

Bushing Gasket Erosion

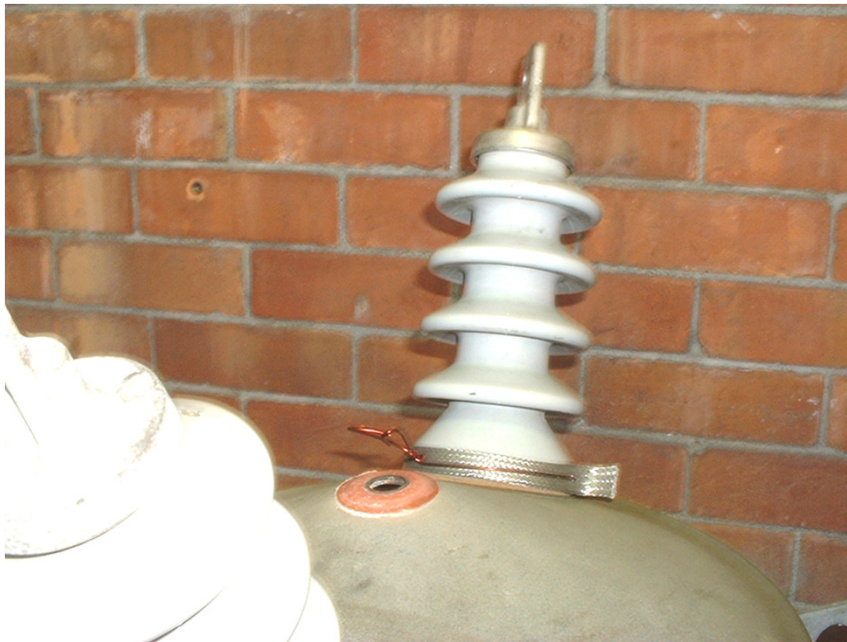
Bushing Model

- One possibility was that partial discharge was occurring across the air gap between the insulator and the tank.
- This was assessed using the following test and carried out by Dr Yafei Zhou of IRL.

1. Replace the existing gasket with a conducting gasket.
2. Apply conducting paint
3. Apply metal foil or braid.
4. On-site repairs.
5. Use metal coating on insulator interface.

- Use conductive coated insulator bases
- Available as standard on 22 kV bushings
- Problem went away following retrofitting campaign
