Conductor Condition Assessment

***EEA Asset Management Forum
20 – 21 June 2017***

***Russell Watson
Network Engineering Manager***

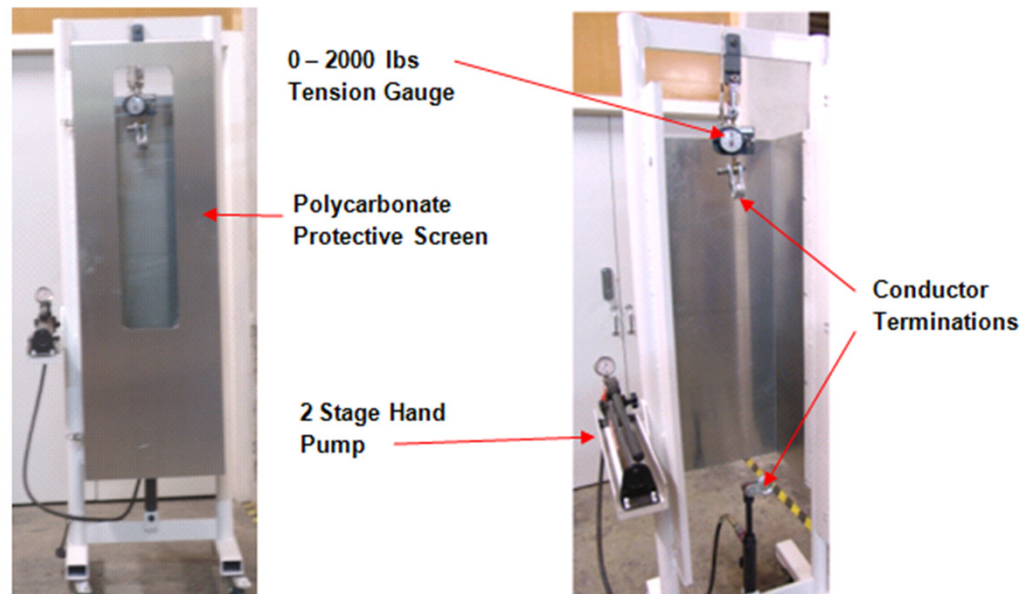
The Tensile Strength Test Rig

- ❑ The wrap test doesn't require any special equipment
- ❑ A test rig was developed for measuring the tensile strength of the conductor strands

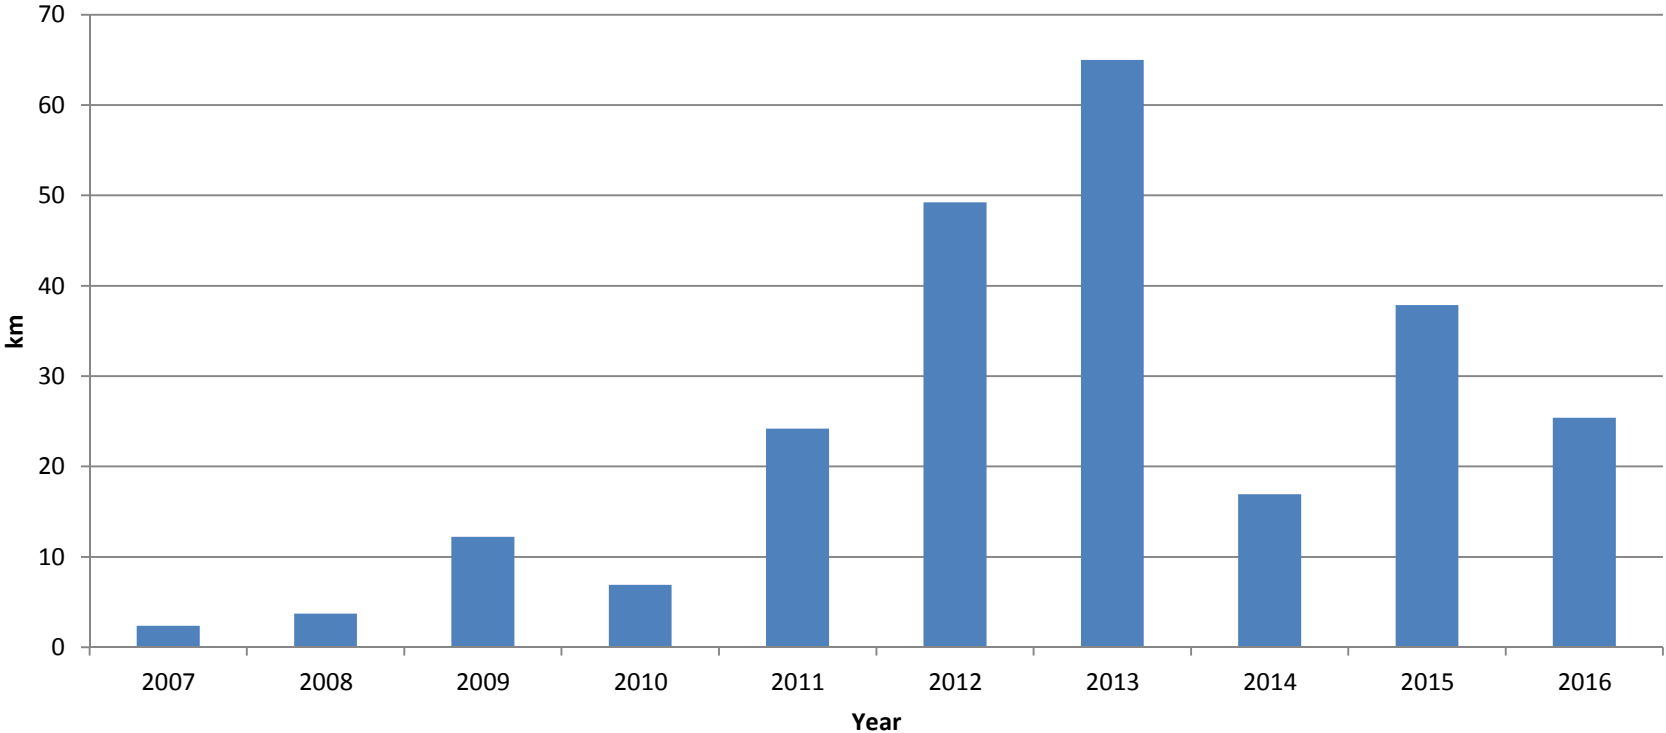
HDBC Replaced

Conductor Replacement
