# Aged Concrete Poles

Michael Whaley, Powerco

21 June 2017

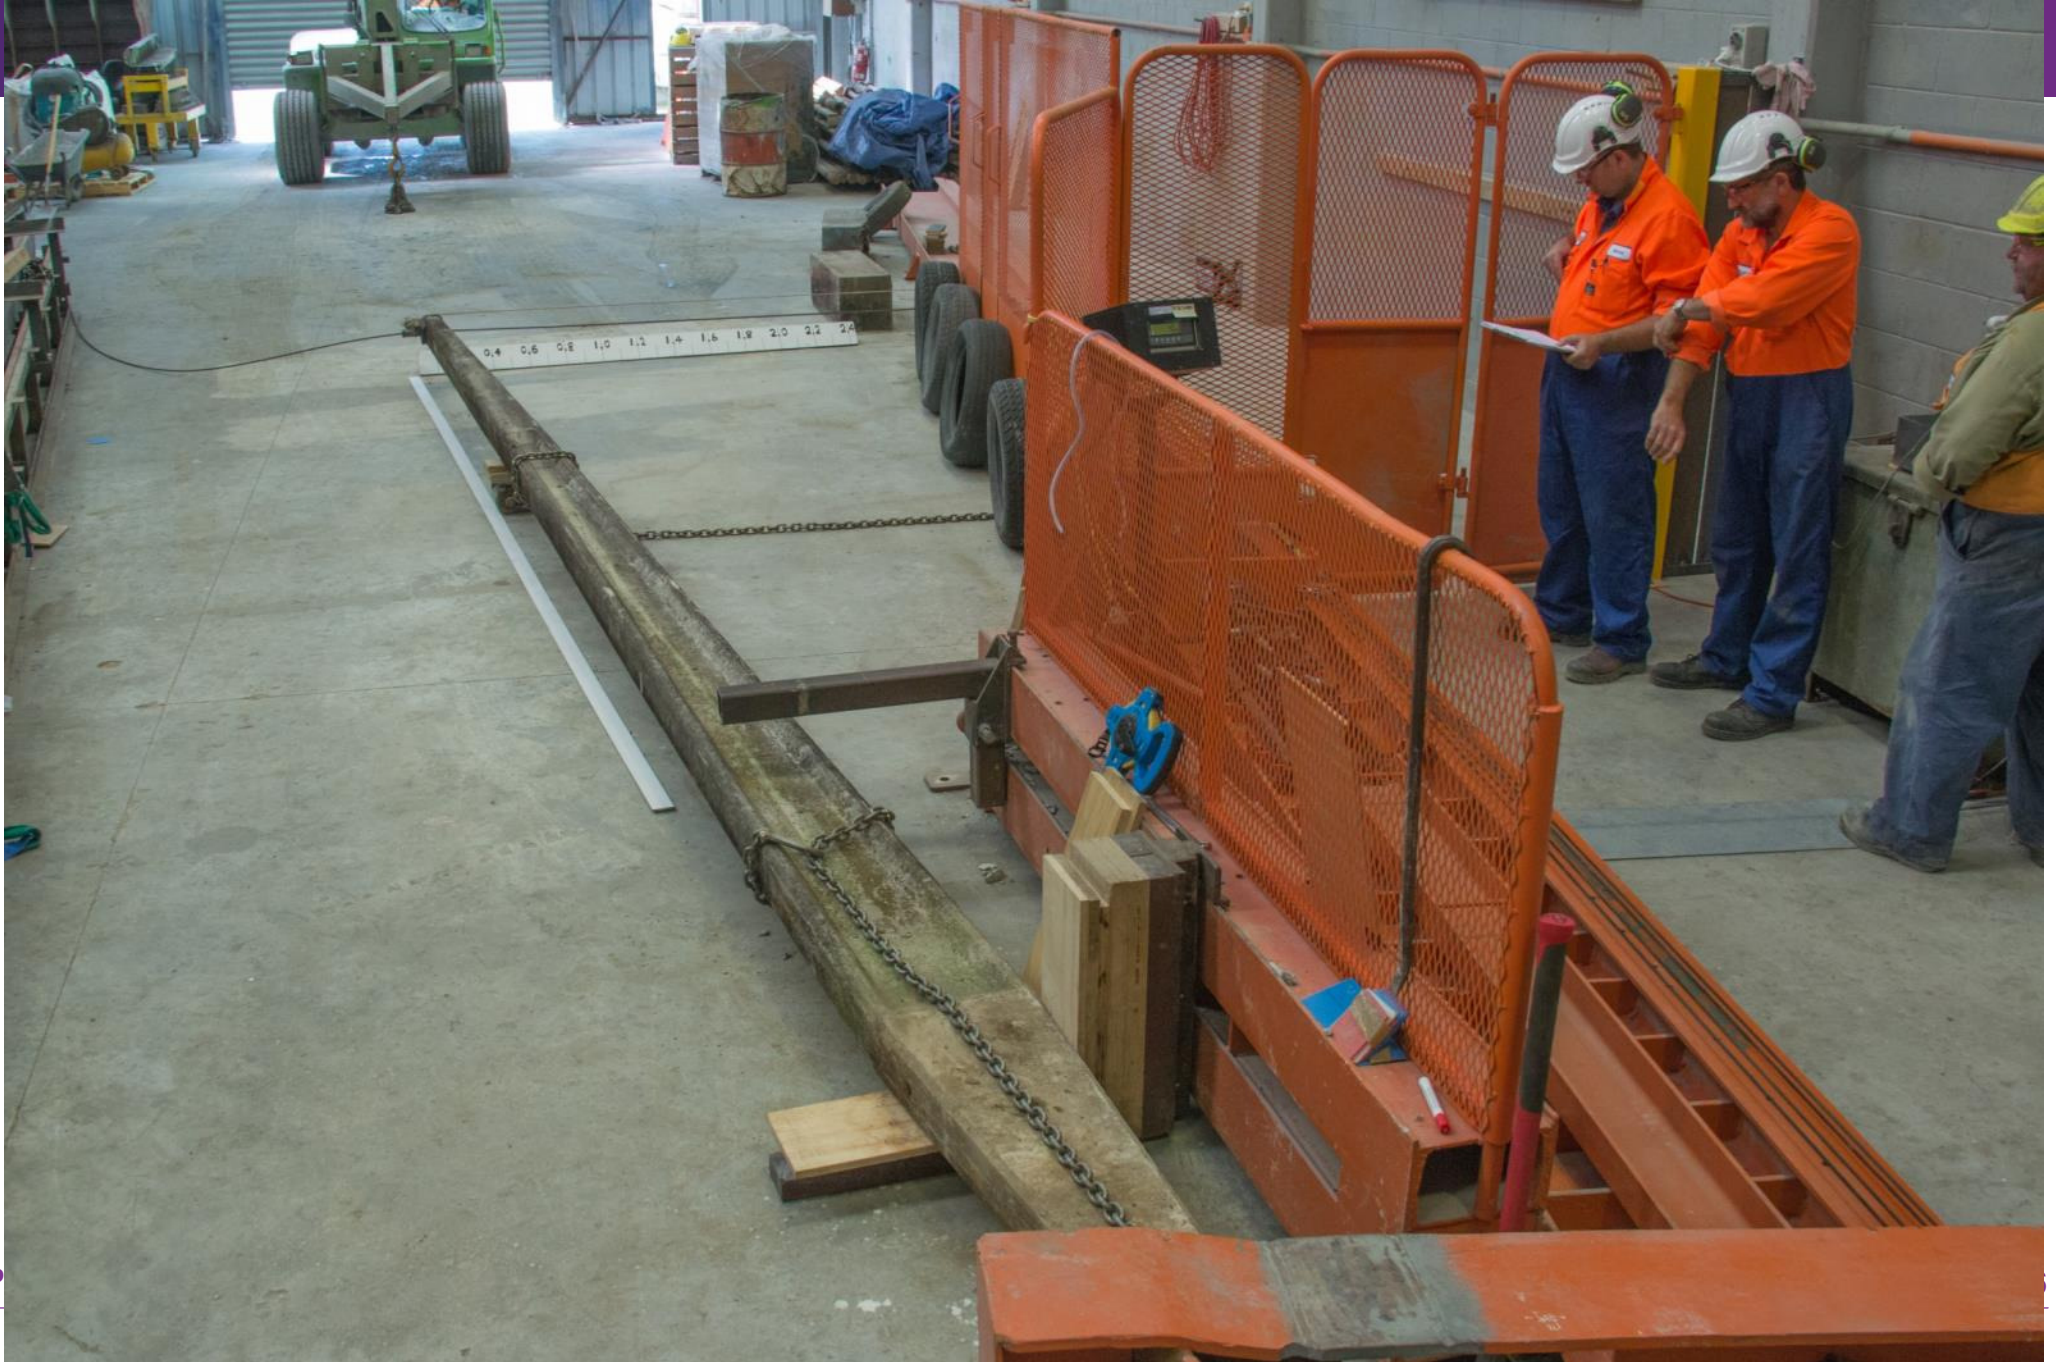
# Cross line pole testing

Tested 3 in  
Down Line  
direction  
and 3 in  
Cross Line  
direction at  
Buscks  
pole  
breaking rig
