# Diagnosing with Data

Robin Pittwood

Powerco / June 2018 / EEA AMG Workshop

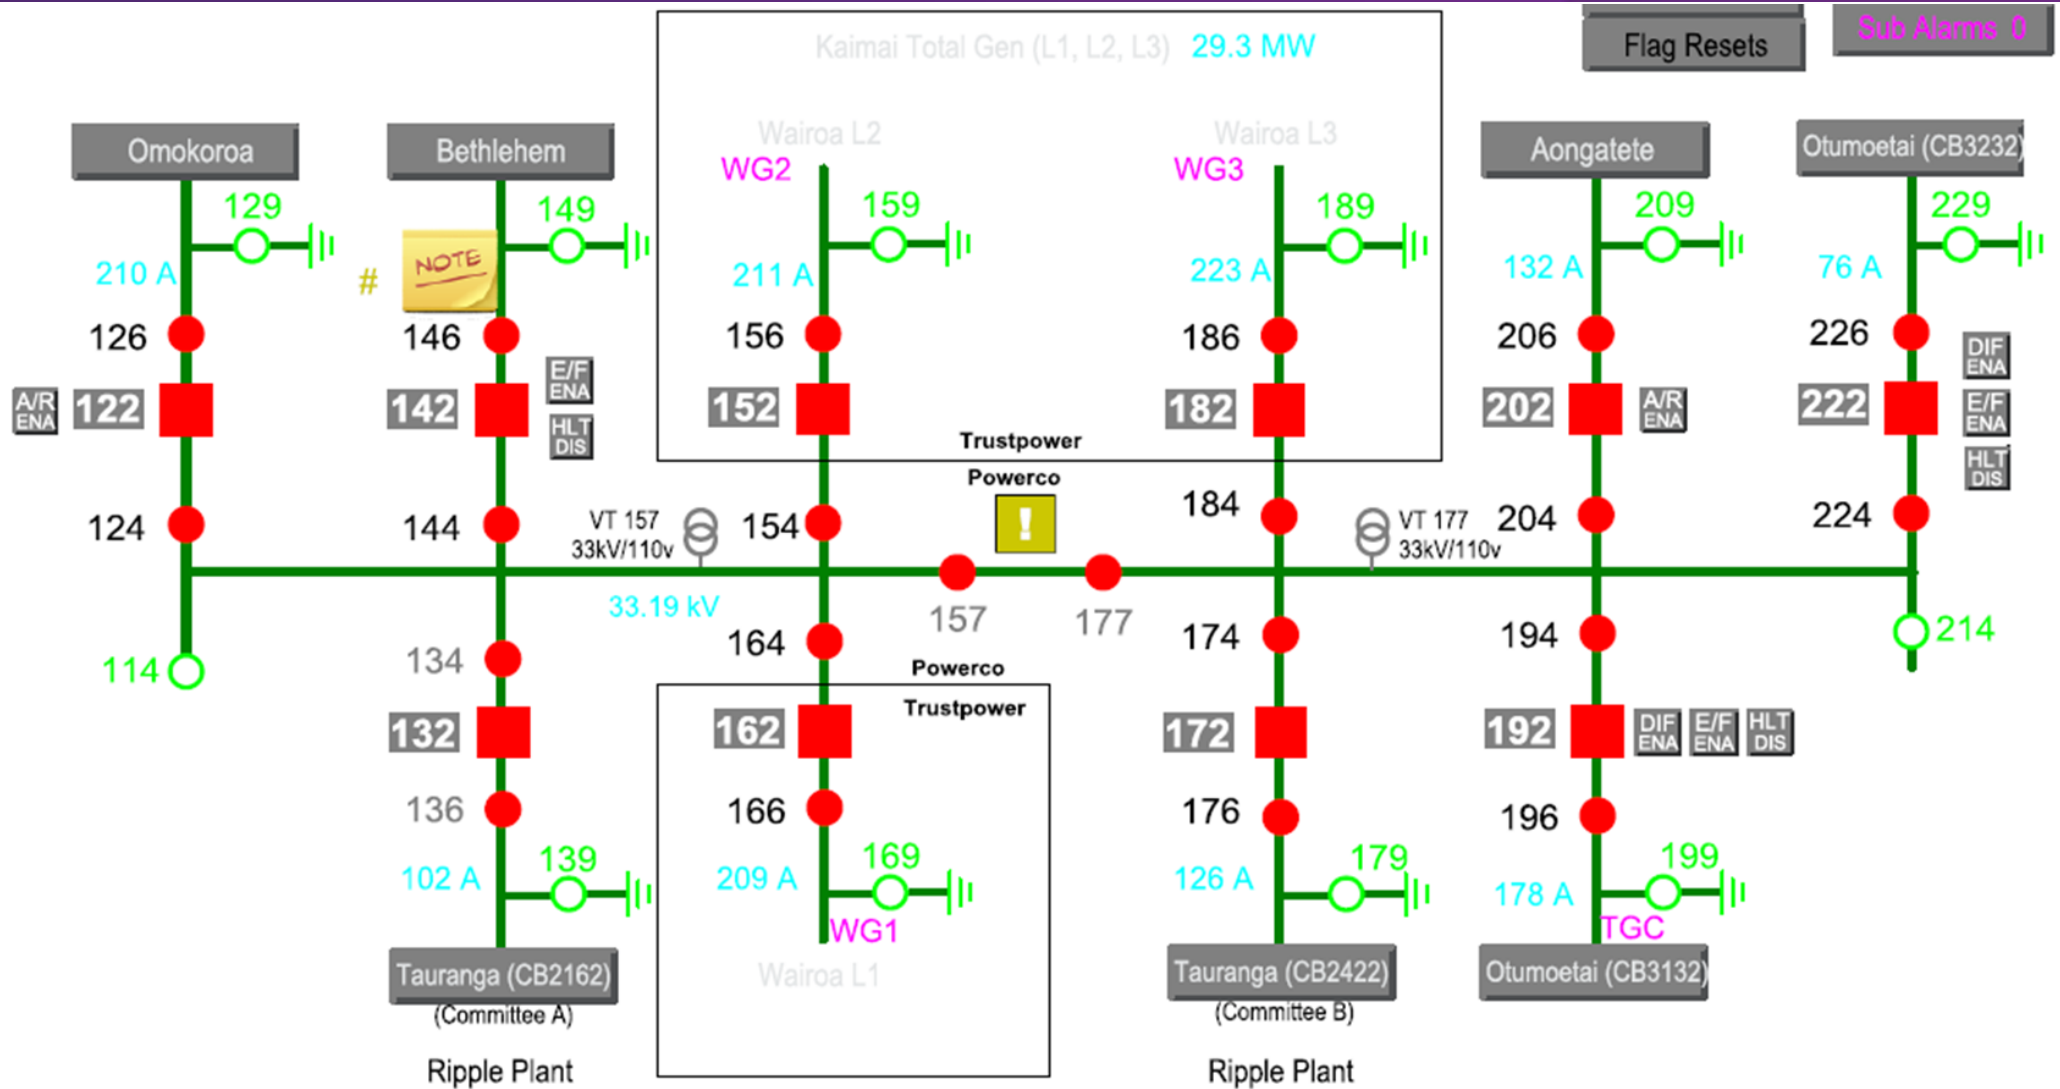
# Switching station outage

- The Substation had experienced a number of unexplained outages over several years. This investigation was for an outage that occurred on 21 Jan 2018.
- Both supplying circuit breakers at the GXP had tripped on earth fault in 1.35 sec.
- The GXP end relays also commanded the substation incoming breakers to open too.
- Three outgoing feeder circuit breakers saw earth fault current about this time, but unfortunately were not satellite clock synchronised.
- One of the three tripped. The other two did not trip.
- What happened?

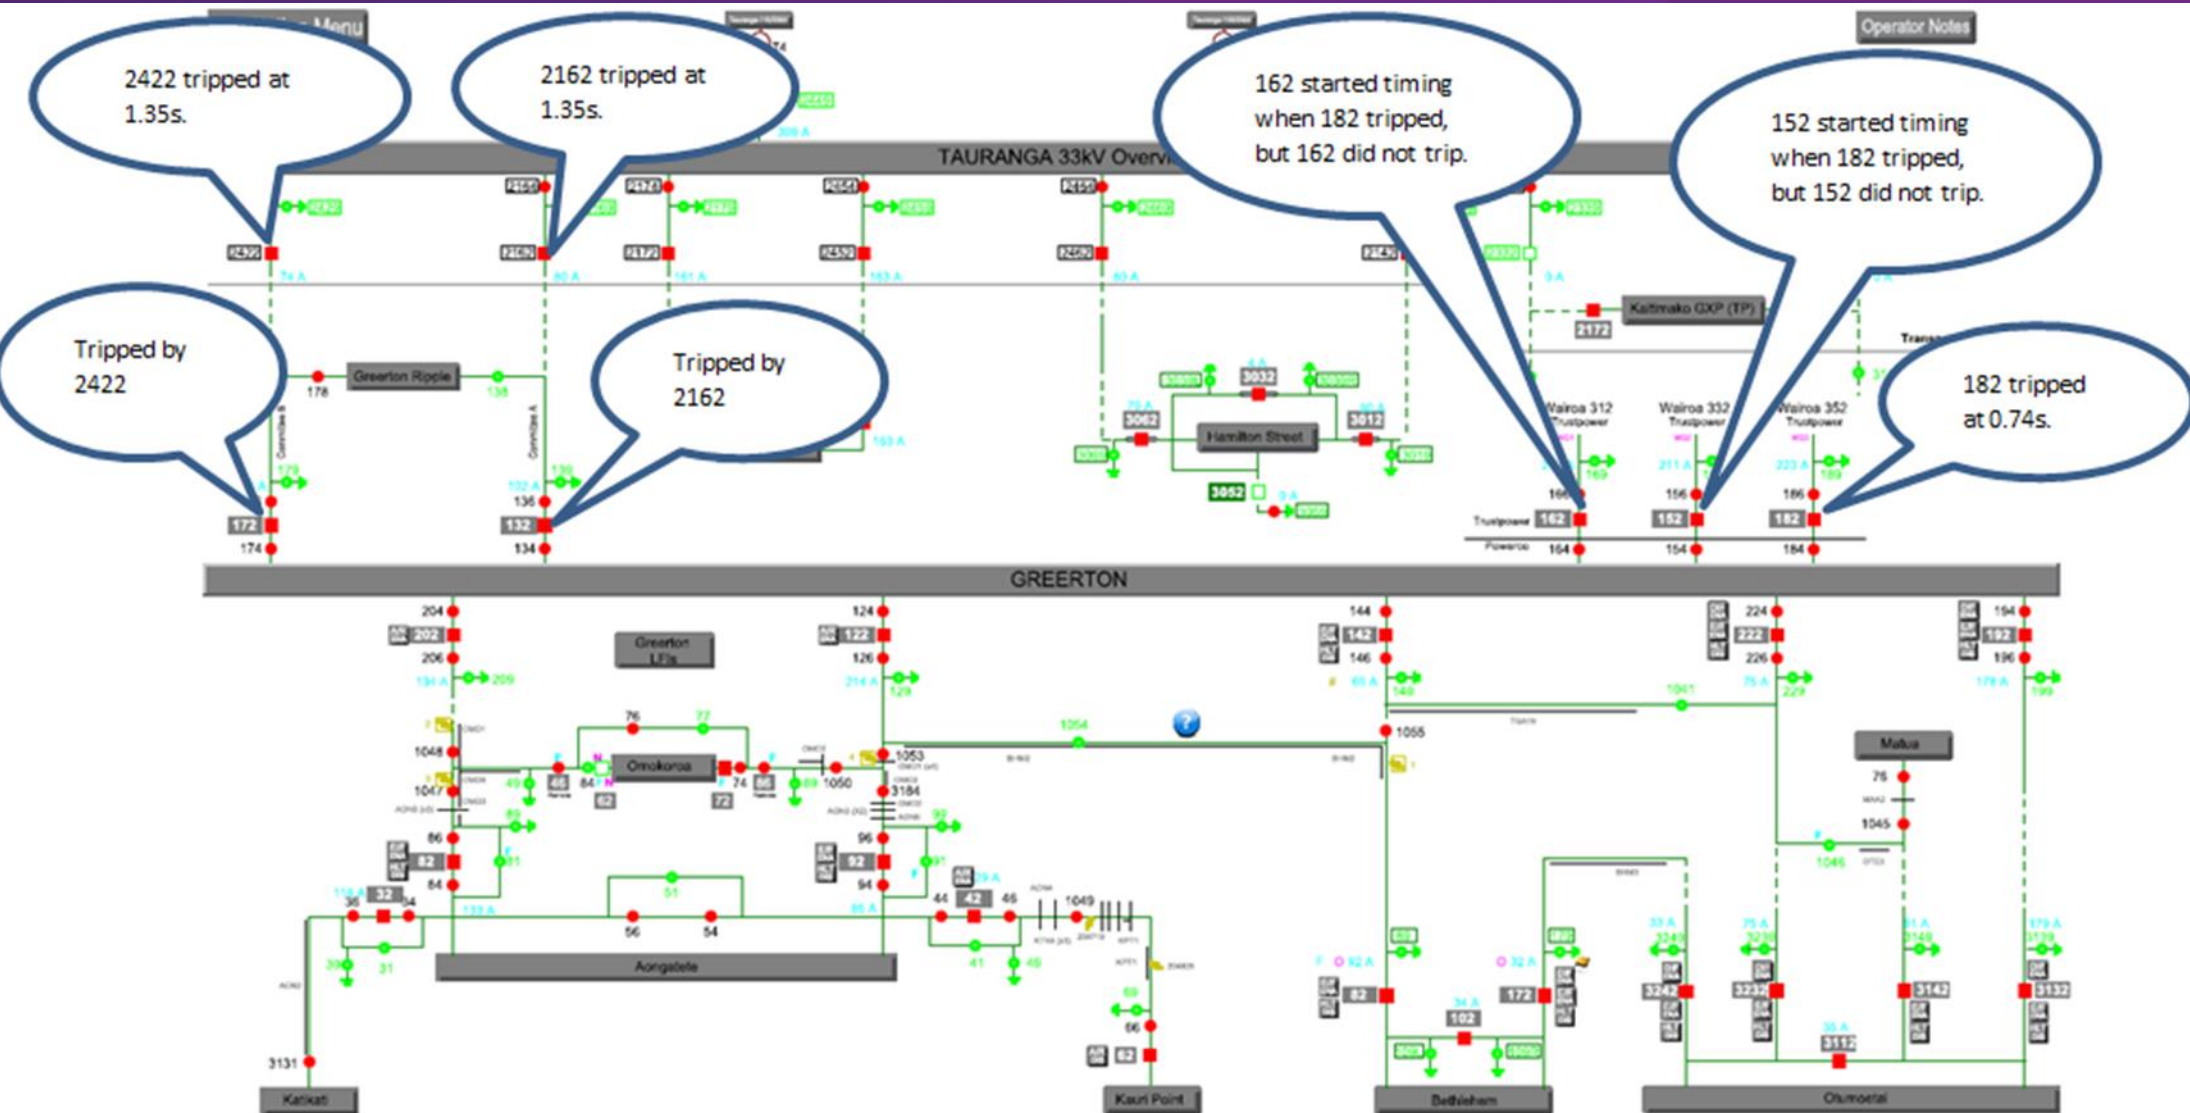
# Substation trip overview and summary

- A 30 millisecond shake in a captured waveform led us to a switchgear fault.
- An inconsistency between zero sequence current and voltage pointed us to a cascade trip issue.
- With a little standard engineering and some standard measurements we can derive some useful system health parameters.
- Are you looking forward to applying some more imagination, incorporating improving measurement technology and analysis tools ...
