# Asbestos in the Electricity Industry

## Shared Learnings

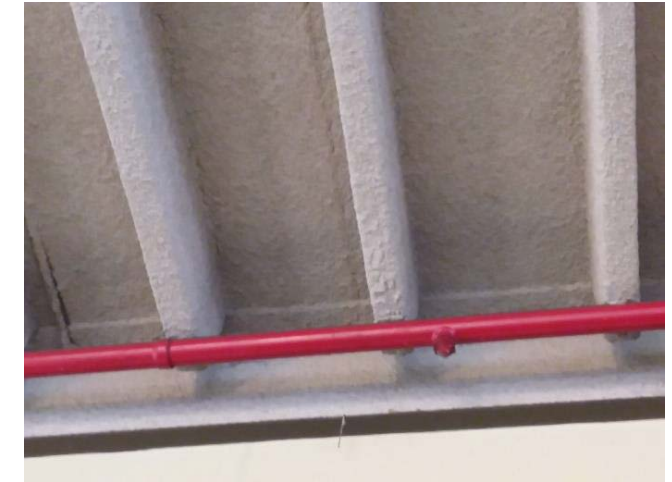
## Textured Ceiling Coatings

Before disturbing any textured ceiling coating ensure you understand if it contains asbestos.

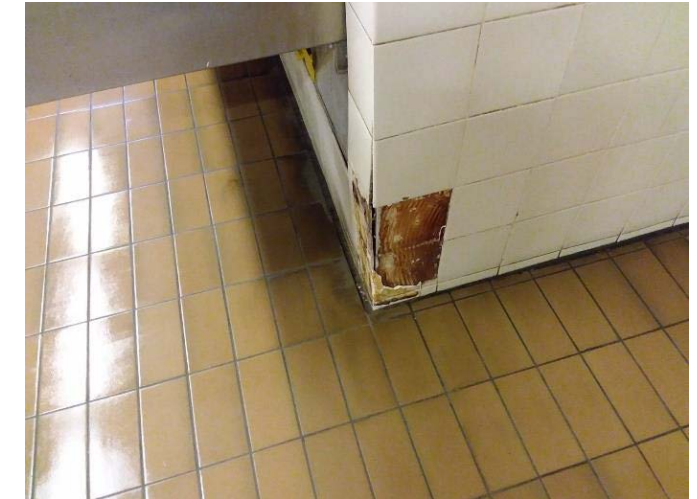
## Glues and Lining Products

Behind tiles and under plasterboard often asbestos contaminated glues or linings are used.
