# SAFETY ALERT

## DROPPED OBJECT – HOLE COVER PLATES

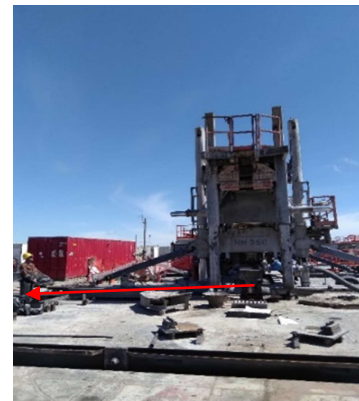
The nearest crewman was approx. 6m from the drop zone

Both plates will be fitted with hinges and secondary retention, so will remain in place whenever this task is carried out.
