Vehicle versus Pole

### Overhead Pole Renewals

### Powerco solution: a location technology approach

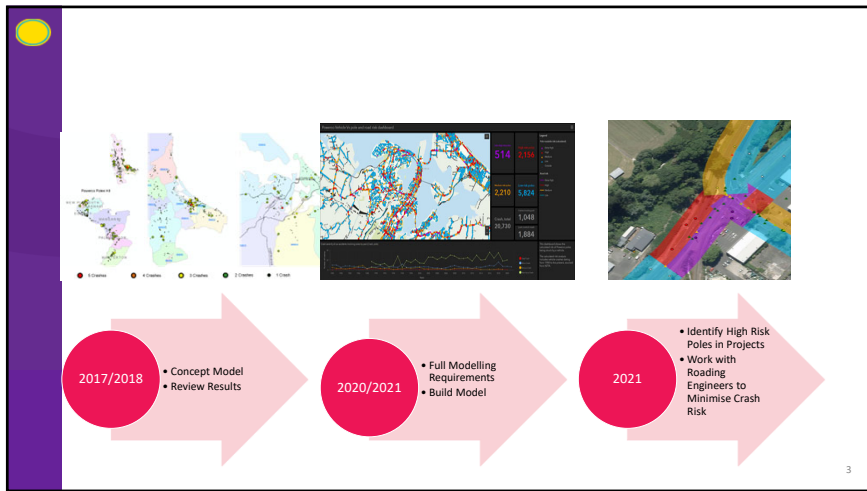
- Replacing 5,000+ poles
- 70% of replacements roadside
- Pole replacements designed for 50 years +
- Opportunity to identify high risk poles and crash sites to design rebuilds for safer roads

A photograph of a street construction site for utility pole renewals. Several white utility trucks with cranes are parked along the road. Workers in orange safety vests are visible. Orange traffic cones line the edge of the road. In the background, there are mountains and a clear sky.

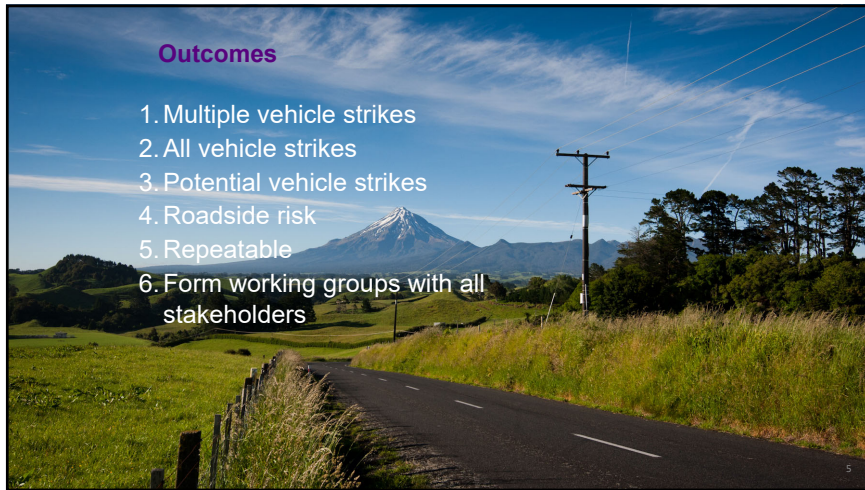
Identified High Risk Poles  
Using Powerco and Waka Kotahi Data (loss of control crashes only)

1. Identified poles hit multiple times
2. Identified over double the amount of pole strikes
3. Identified poles of interest

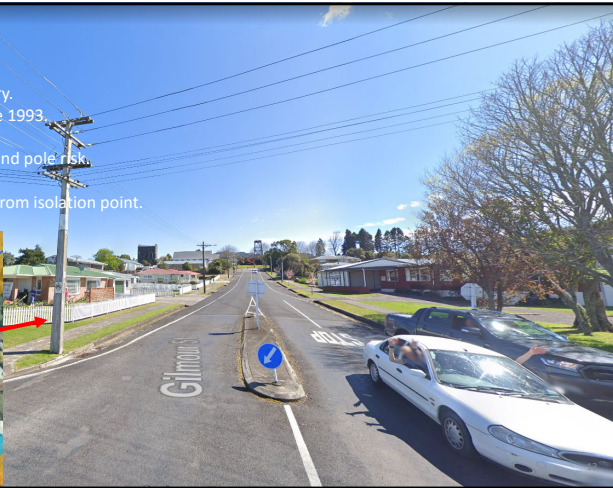
## Case Study 2 Waihi

- Pole ID: 301635.
- One car vs pole crash noninjury.
- 34 Crashes near the pole since 1993.
- No fatal or serious crashes.
- Extra high road risk segment and pole risk.
- 794 Customers on this feeder.
- 284 Customers down stream from isolation point.

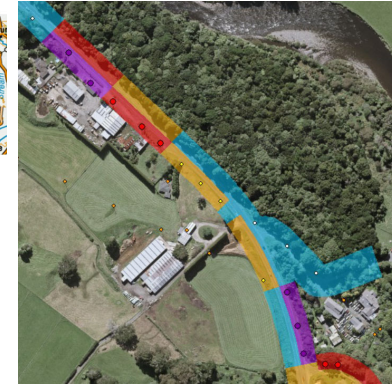
Safety Upgrade State Highway 3 New Plymouth to Egmont Village

- ☑ Poles roadside\_risk
  - Extra High
  - High
  - Low
  - Medium
  - Outside
- ☑ Roadside\_Risk
  - Roadside\_RiskClass
    - Low
    - Medium
    - High
    - Extra high
