Shared Learning

Critical Risk: Dropped Objects

Think ahead to engineered solutions

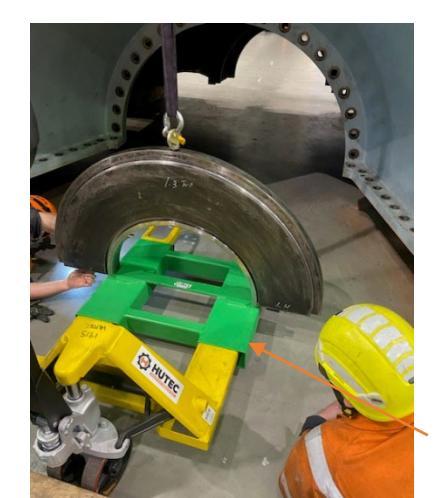
2. A smaller packing head on the IP casing requires fitment before installation (unlike the larger packing heads rigged and fitted directly from above the turbine). This smaller packing head has often been supported by dunnage or by persons when being installed.

Specialised packing head jig bolted from underneath

An engineered jig was built overnight to be able to support this packing head, being fully stable once bolted from underneath
