Safety Alert

Chance makes his presence felt in Auckland

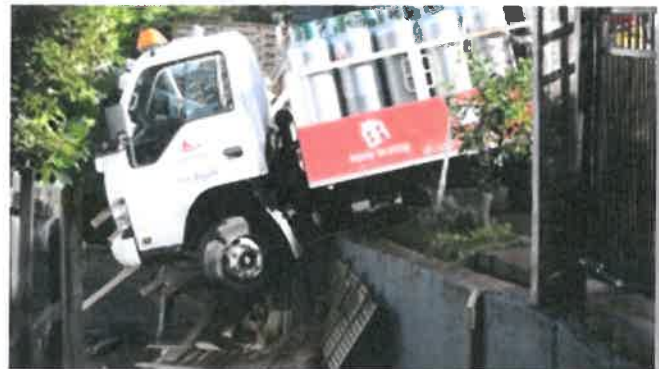
An LPG delivery driver sustained injuries to his leg, torso and arm after being run over by his vehicle during a routine delivery in Auckland last week. The runaway vehicle rolled down an incline damaging a fence and pergola before coming to rest on a retaining wall.

As the driver was parking the vehicle he received a call on his Radio Telephone (RT) and, as a result of the distraction, overlooked engaging the handbrake. As he got out of the vehicle it began to roll forward, catching his foot under the wheel of the vehicle, and knocking him over.

We need to ensure the integrity of our safety systems so that there aren't any gaps for Chance to make his wicked way through. This includes things such as fitting our delivery vehicles with alarms that alert the driver when the handbrake needs to be engaged. We need to apply our 'Safe to Run' lens to all of our operations by asking ourselves three fundamental process safety questions:
