SAFETY ALERT

Oily Rag Amnesty

26 September 2014

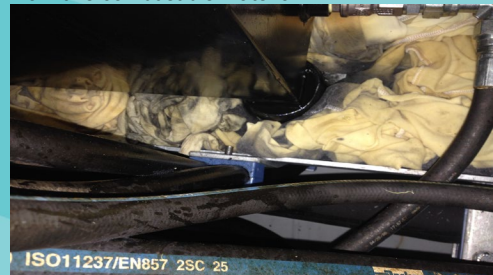
During the work it was observed that a large number of oily rags had been used to soak up old oil around the hydraulic station and then left in situ. There had been no oil leaks reported or identified. There has been a report from the same contractor that the hubs have had oil leaks which have not been reported or identified as a hazard.

This was identified by the contractor as a serious fire hazard.

From this combustible material

Good housekeeping is a requirement of all Meridian Wind technicians and our contractors as a non negotiable. The reasons are plain to see:

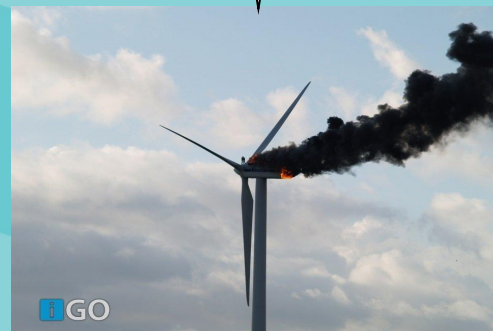
PHOTO:

To this
