### Disturbed Asbestos

### Powerhouse

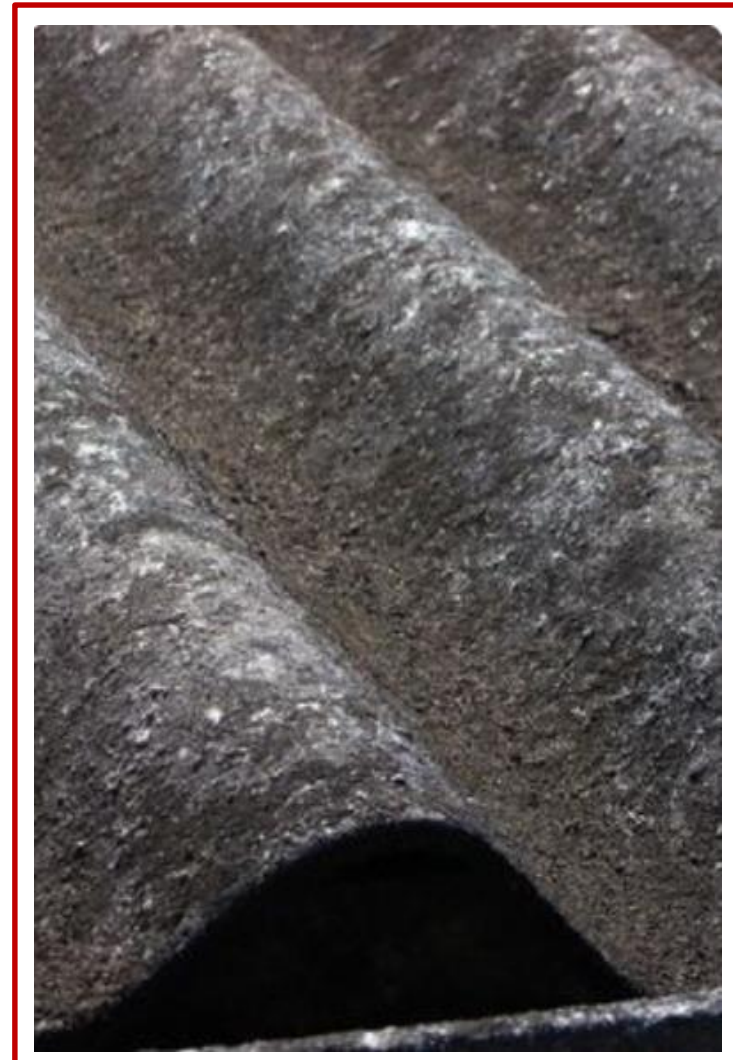
Powerhouse roof identified as low risk Asbestos Containing Material disturbed by birds resulting in chunks of material containing chrysotile and amosite falling from roof on to floor of station.

Fibres have not been detected in air monitoring test at ground level of station; however airborne fibres will be produced when material falls to ground.

Clean of station and review of roof condition including animal control.

Consider within Asbestos Management Plan how condition monitoring will be carried out (in particular for challenging locations) and include the appropriate frequency.
