Li-Ion Battery Fire – Portable Grinder

Hydro Scheme

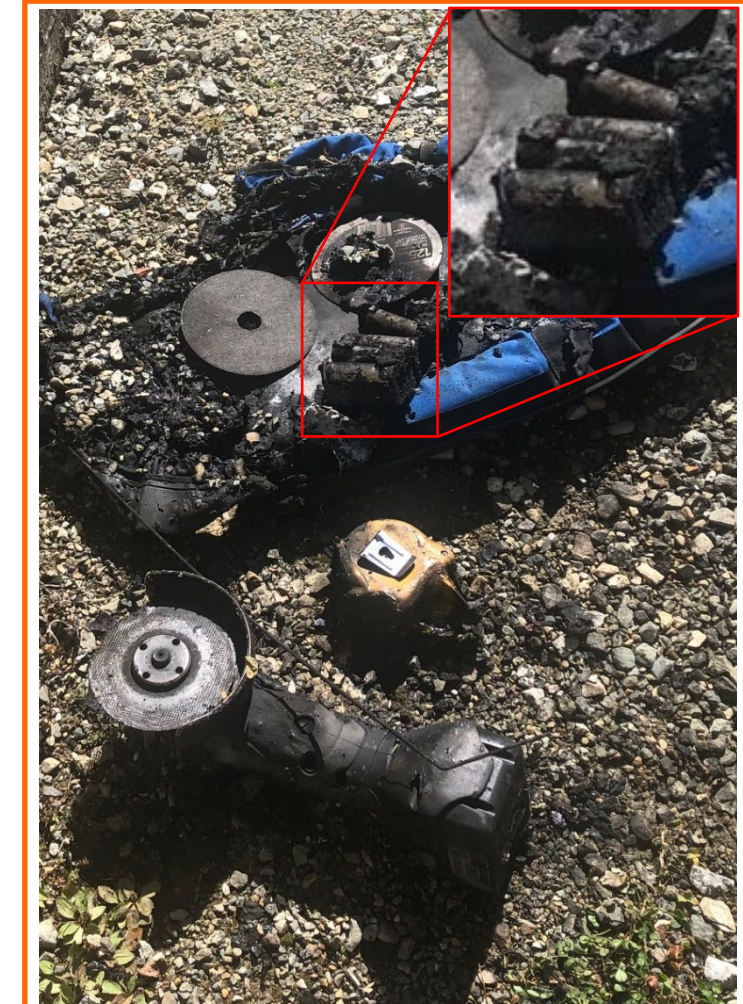
On inspection it looked like the first battery used (which was now loose in the bag) had self ignited and burnt the bag and its contents. On closer inspection it appeared that the possible cause was an internal short/damage of one of the battery cells rather than an external short across the battery terminals.

- Visually check for damage to the battery case before and after use.
- Store Li-Ion batteries securely. Ensure they are protected from damage.
- Remove old batteries from service (typical usable life for standard Li-Ion tool batteries is 3 years).
- Do not leave Li-Ion batteries on charge after they are fully recharged.
