Hand Laceration

Machining Workshop

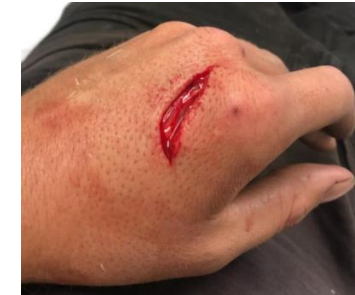
Another staff member was supporting the piece ready for it to part using a wooden dowel of which the dowel was drawn sideways catching the persons hand between the part and tool post. A laceration was received with surgery required to repair a tendon and a minimum of 4 weeks off work.

Hand Injury received

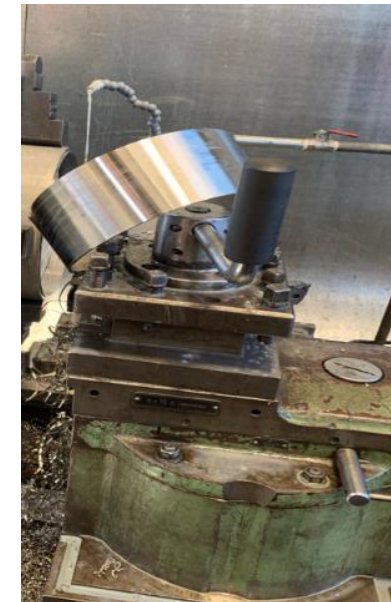
During the lathe parting off process of a irregularly shaped 250mm diameter piece of pipe, the parting tool caught the inside edge of the pipe causing the cut piece to flick sideways landing on the tool stock.

Final resting location of off cut on tool post

1. Larger diameter irregularly shaped pipework requires additional controls to manage risk. One alternative is to support with the tailstock or remove the piece and make the last cut using a band saw or grinder blade
2. Additional peer/supervisory support may have helped in this situation to discuss the best process to use

We have since updated safe work practices and signage to confirm the requirement to peer review any parting of irregularly shaped items, whilst reviewing other regular workshop practices to ensure current risk controls are still adequate
