## Crane hook caught on High Pressure Vessel

## Location: Karapiro

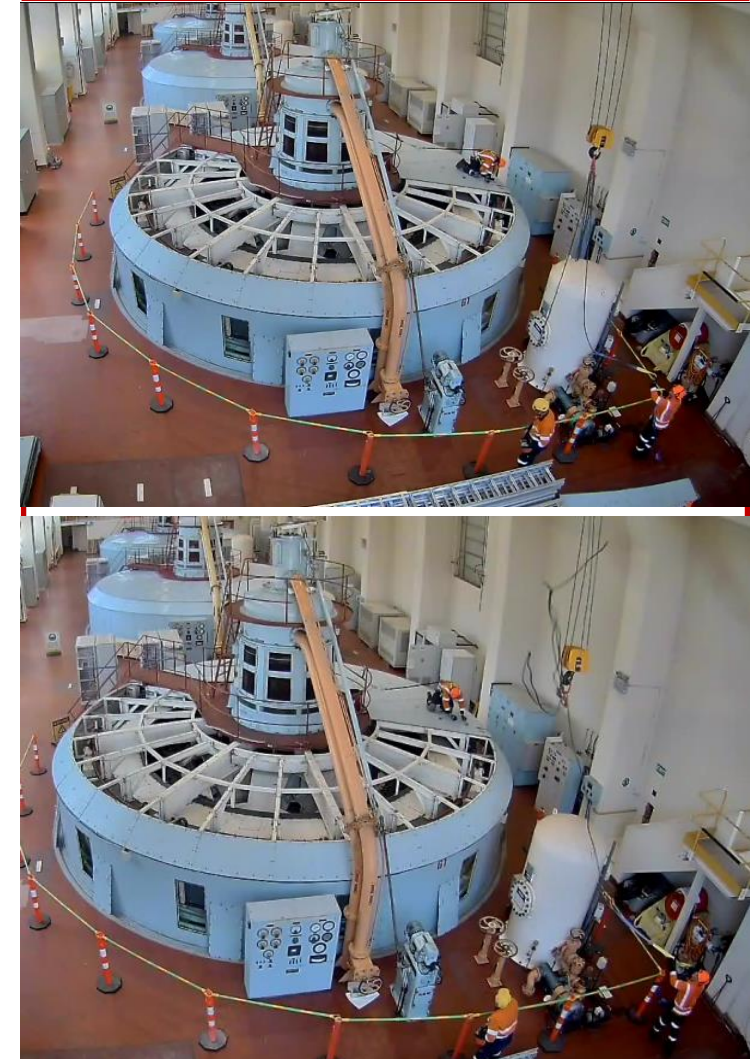
Whilst removing generator covers during a Class 2, the crane operator traversed an empty crane with a loose hook over the Governor on the generator floor.

The hook snagged on the a bolt of the governor hatch door then released under pressure, resulting in the hook flying into the air.

Other than a bent crane hook, there was no injury or asset damage, however the potential for the same was substantial, should the hook have connected with a worker working in the vicinity.

- Empty cranes can be as dangerous as loaded cranes
- All crane chains need to be guided when traversing the crane
- A walk down and visual inspection of the area prior to the job commencing to identify hazards is recommended prior to all lifts
- Lift plans should include floor sketch plans to identify safe “laydown” areas
- DO NOT traverse loads or empty cranes over any high pressure equipment
- Ensure all team members are involved in hazard identification prior to work commencing.
