SAFETY ALERT

Broken Chain Breaks Rear Window of Bulldozer

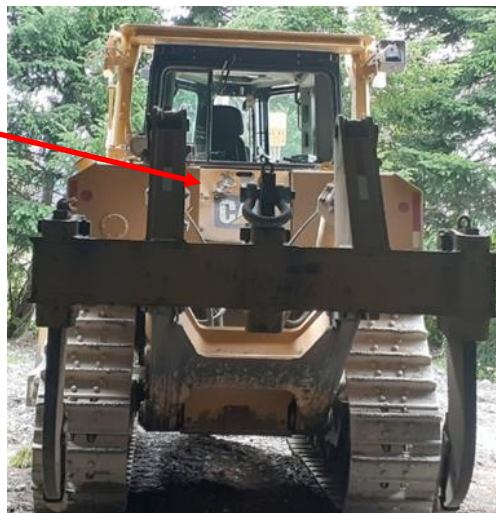
A fallen pine tree and root ball was in a position where it could fall into the canal. While trying to remove the tree it was first loosened up with the bulldozer. A towing chain was then attached to tow the tree free. As weight was placed on the chain it broke about 1/3 of the way along the length resulting in the chain recoiling and striking the back of the bulldozer with the broken end of the chain hitting and smashing the back window.

Chain struck bulldozer here and then broke the rear window.

- Ensure towing equipment is correct for the job and in good condition
- Use a weighted winch bag when towing to prevent recoiling if the rope or chain breaks

- Even if you have done this in the past step back and assess before starting, consider all the potential risks each situation will be different
- Ensure all people involved are aware of what to do and clear of the area before starting to tow
